Southwark Council

Ledbury Estate

Structural Robustness Assessment
for Large Panel System Tower
Blocks with Piped Gas

Issue 2 | 30 August 2017

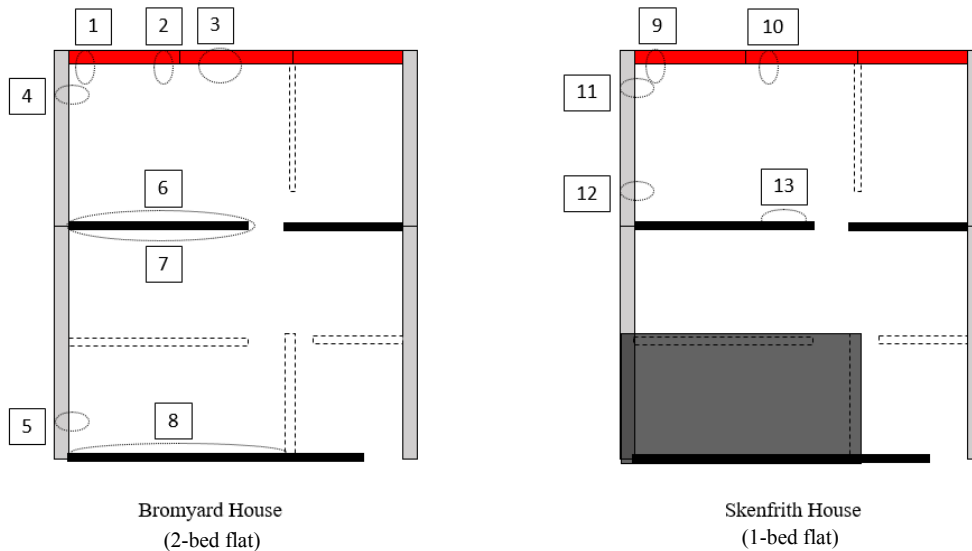
The locations of the investigation works undertaken are shown in Figure 4. While the two flats have the same general layout, the flat in Bromyard House has two bedrooms, while the flat in Skenfrith has one bedroom (the room shaded grey in the sketch below is the third bedroom to the neighbouring flat). This sketch is referred to throughout the following Section.

Figure 4 Floorplans of the two flats showing the locations of the intrusive investigation works

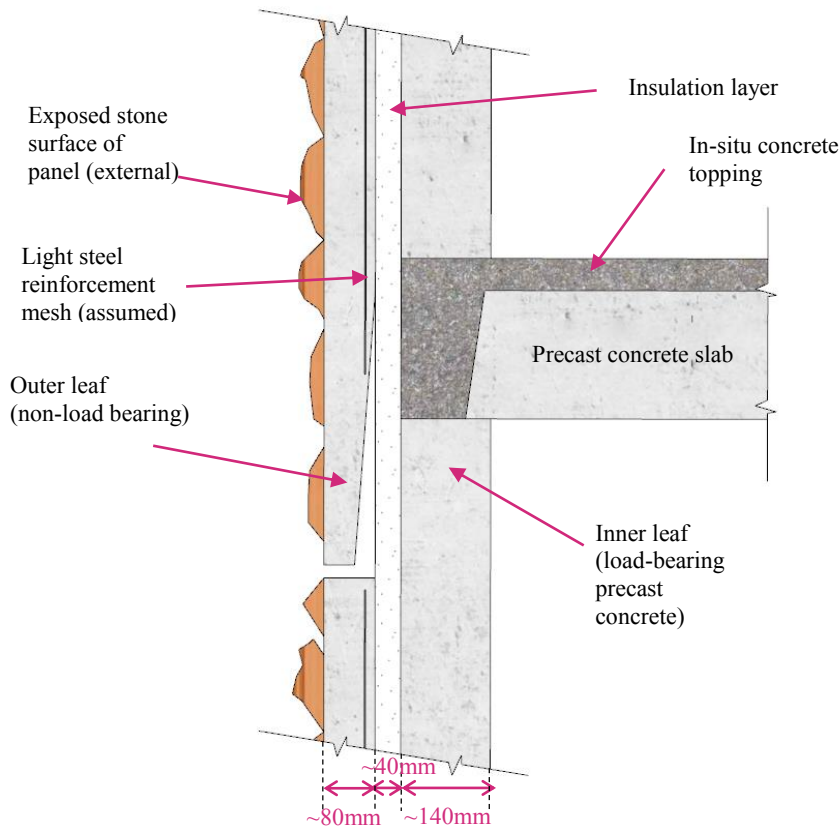
A sketch of the cross-section of a flank wall panel, based on the investigation findings, can be seen in Figure 5. The panels consist of two concrete leaves separated by an insulation layer. The inner leaf of the panel bears all of the vertical load provided by the slabs (i.e. the weight of the building goes through the inner leaf). The outer leaf simply provides the weather proofing skin. As a result, our investigations focussed on the inner leaf.

Figure 5 Cross-section of the flank wall panel

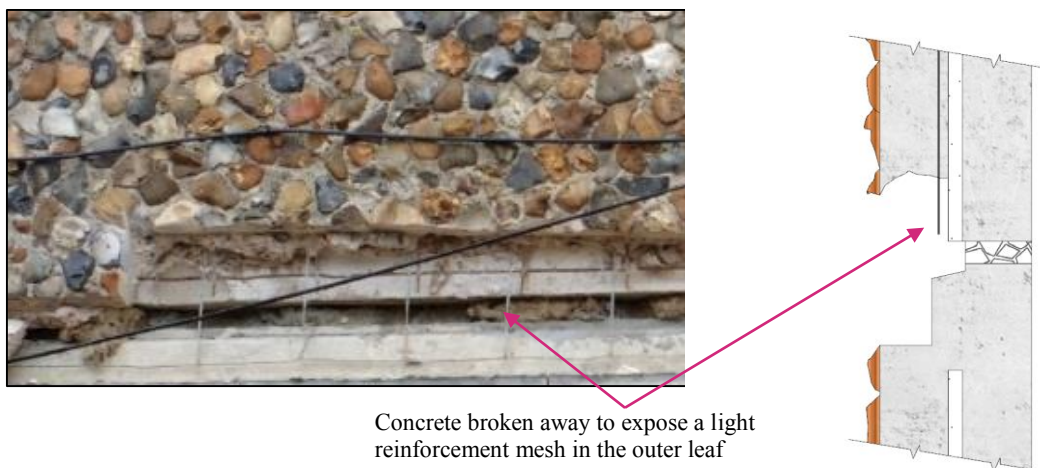
Figure 6 Light reinforcement mesh in the outer leaf of a non-structural wall panel. Photograph looking straight at the panel (LHS). Sketch showing a section through the wall panel, demonstrating the extent to which the concrete was broken away (RHS)

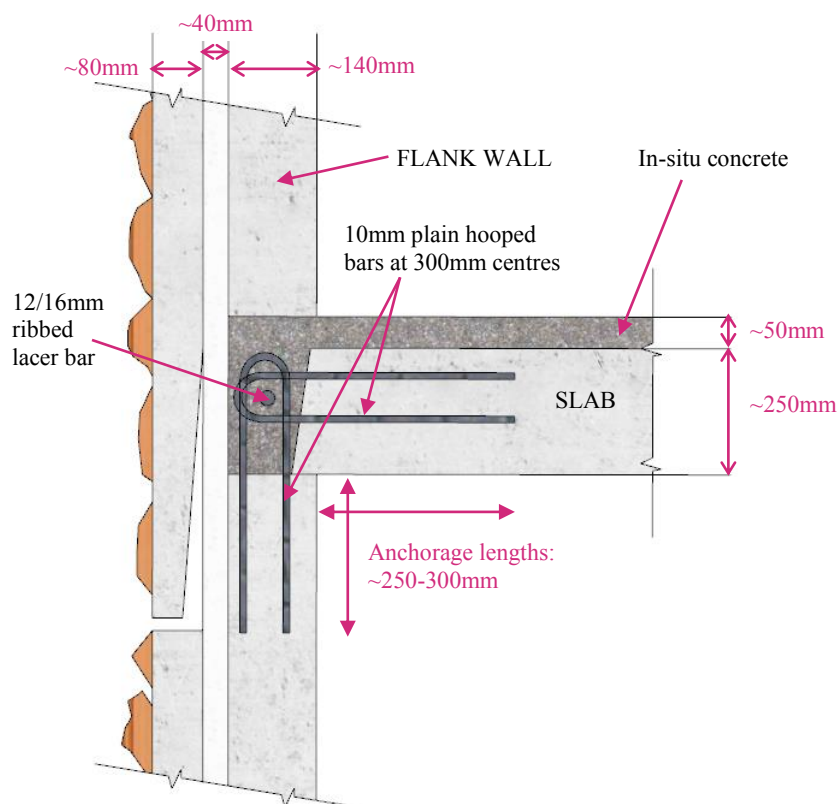
Interlocking reinforcement between the top of the flank wall panels and the floor slabs was found; located at 300mm centres. A sketch of this detail (based on the investigation findings) can be seen in Figure 7. Three fixings were exposed; two at location 3 and one at location 10 (seen in Figure 4).

10mm diameter plain hooped bars extend from the top of each flank wall panel and from each slab. These hooped bars are linked by a horizontal ribbed ‘lacer’ bar. These lacer bars were observed to be 12mm in diameter in Skenfrith House (location 10) and 16mm in diameter in Bromyard House (location 3). At location 3, two bars were discovered indicating a position of a lap. The voids between the precast panels are filled with in-situ concrete.

Plain bars circa 1968 suggest ‘R’ type bars with a characteristic yield strength of ~250MPa. Ribbed bars suggest ‘T’ type bars with which typically had a characteristic yield strength of ~410-450MPa.

Figure 7 Flank wall panel to floor slab fixing detail

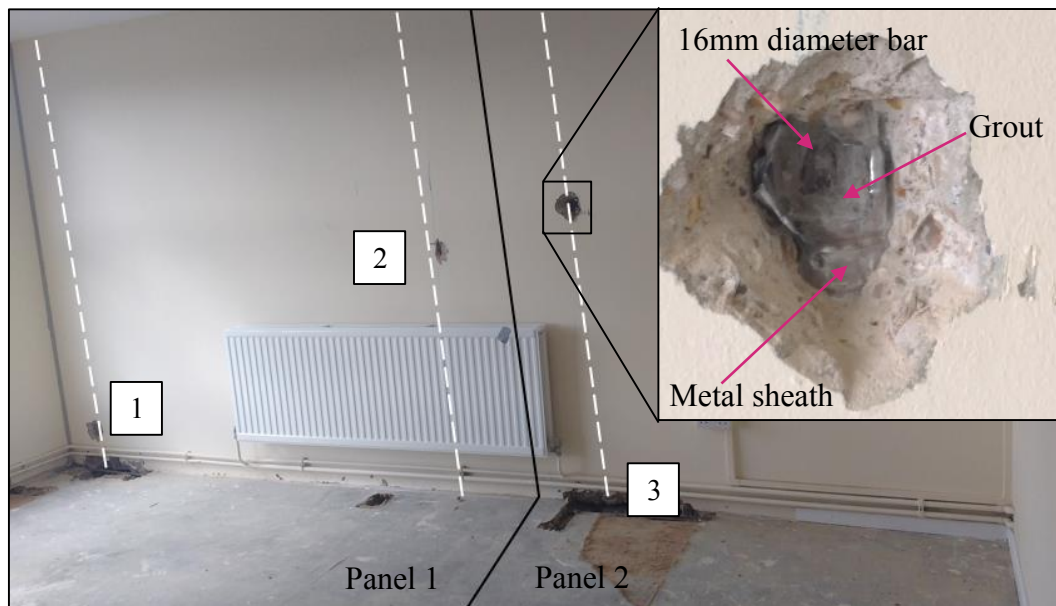
Each flank wall panel is connected to the flank wall directly above and below by two vertical 16mm diameter ribbed steel reinforcement bars at either side of each panel. These bars are contained within 45mm diameter metal sheaths which were fully grouted at the exposed locations. The non-destructive scanning tools detected that the sheaths extend the full height of the panel and local break-outs revealed that the vertical steel bars extend into the in-situ concrete joint (between the wall and slab). The extent to which the base of the fixings were exposed at the base of the wall panels can be seen in Figure 11. Sketches of this fixing detail (based on the investigation findings) can be seen in Figure 9 and Figure 10. A photograph showing locations 1, 2 and 3 (Figure 4) can be seen in Figure 8.

Figure 8 The locations of the vertical bars in the flank wall panels (located by electromagnetic scanner), are shown in white. The close-up photo shows an exposed metal sheath and bar at mid-height

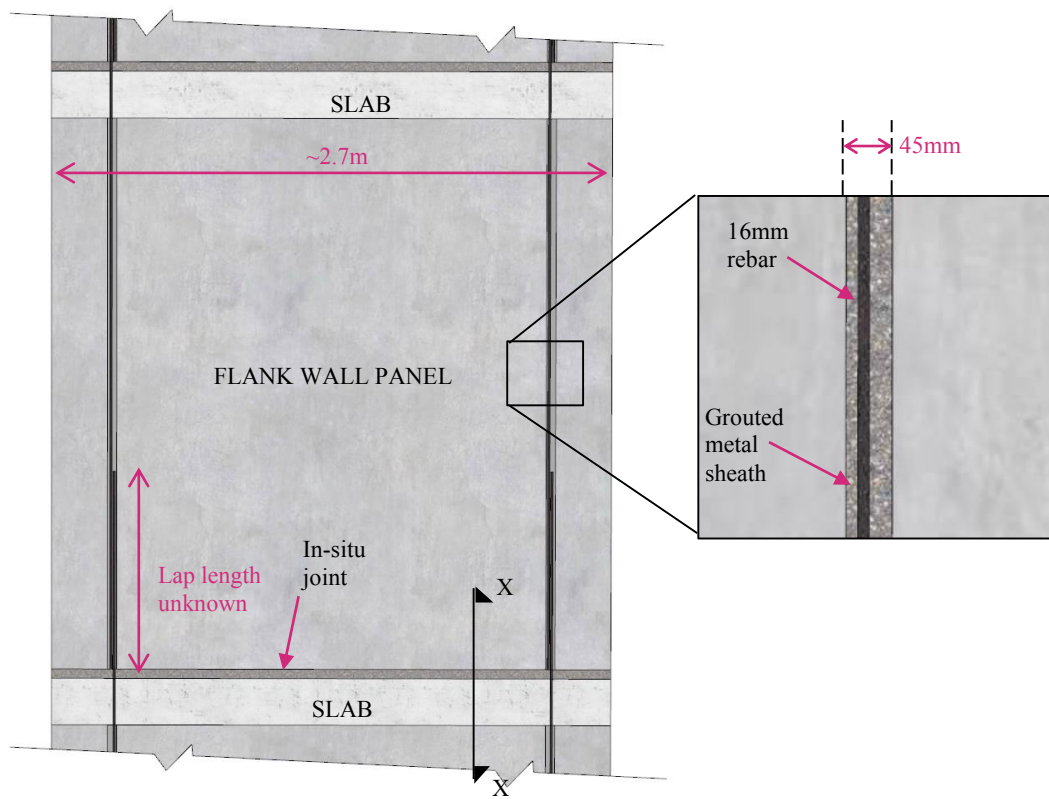
The location of each vertical joint was initially located using the non-destructive scanning tools and four locations were subsequently intrusively investigated; locations 1, 2, 3 and 9, as seen in Figure 4. At location 1, the base of the joint was exposed and two steel bars were observed, this is assumed to be the lapping of the vertical bars, one bar ends just below the bottom of the sheath and one bar extends into the in-situ joint. At location 2, the sheath and bar were exposed at mid-height – a single bar was found. At location 3, both the base and top of the joint was exposed. In both instances a single bar extending into the in-situ joint was observed. The bar and sheath was also exposed at mid-height at this location; again revealing a single bar. At location 9 the base of the joint was exposed and a lapped detail similar to that at location 1 was observed.

Figure 9 Flank wall to flank wall fixing. One flank wall panel is shown

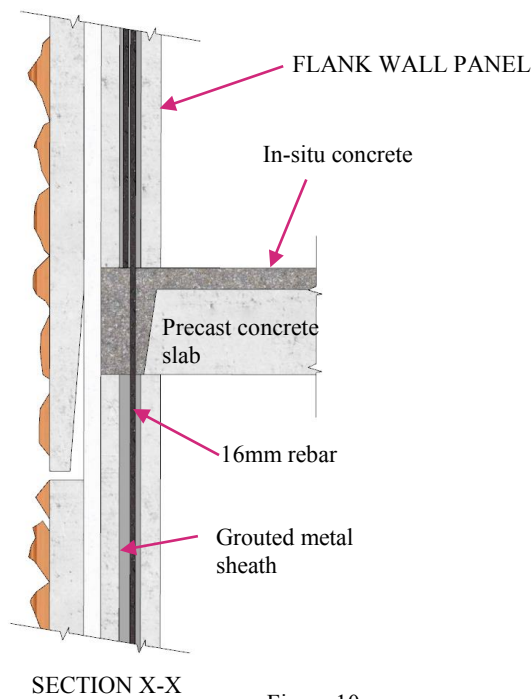
Figure 10 Flank wall to flank wall fixing, Section X-X (taken through the joint)

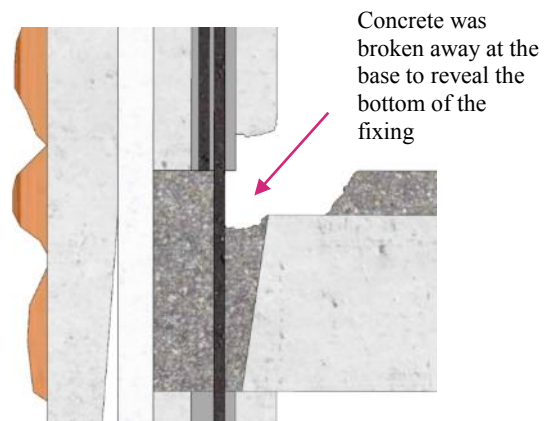
Figure 11 Flank wall to flank wall fixing, illustration of extent of break-out

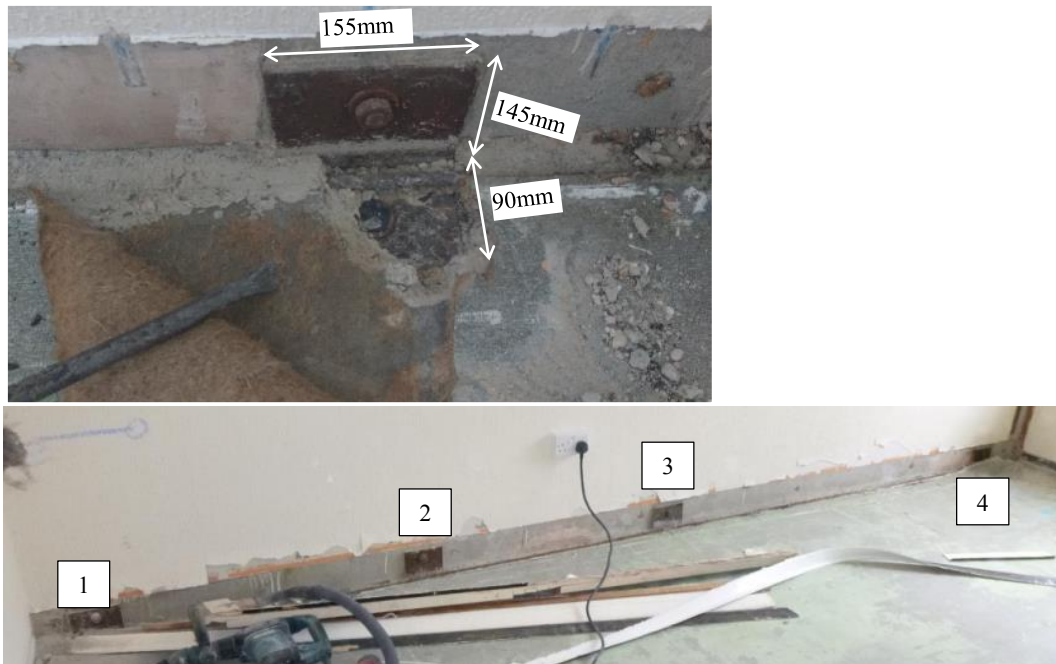
Removing the skirting boards along the base of the load-bearing cross-walls in Bromyard House revealed 10mm thick, steel L-brackets (see Figure 12) bolted to floor slabs and walls at locations 6, 7 and 8 (Figure 4). Four brackets are spaced along a length of ~5m at location 8 (Figure 12), while three brackets are spaced along a length of ~4m at locations 6 and 7. No L-brackets exist at ceiling (soffit) level. No further investigations were undertaken on these cross-walls.

Figure 12 Bromyard House – L-brackets were found along the length of the cross-walls (location 8)

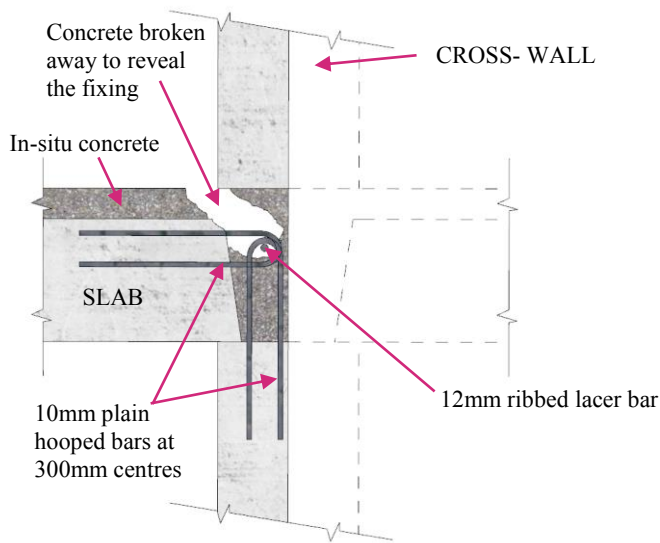
No L-brackets are present along the cross-walls in Skenfrith House. However, interlocking reinforcement at 300mm centres tying the top of the cross-wall panels to the floor slabs (similar to the flank wall fixing described in Section 3.2.4.1) was found at location 13 (Figure 4). The extent to which the joint was exposed can be seen in Figure 13. The joint was only exposed from one side, the dotted outline of Figure 13 was not investigated.

Figure 13 Skenfrith House: cross-wall to slab fixing, illustration to show extent of break-out. Only one side of the cross-wall was investigated

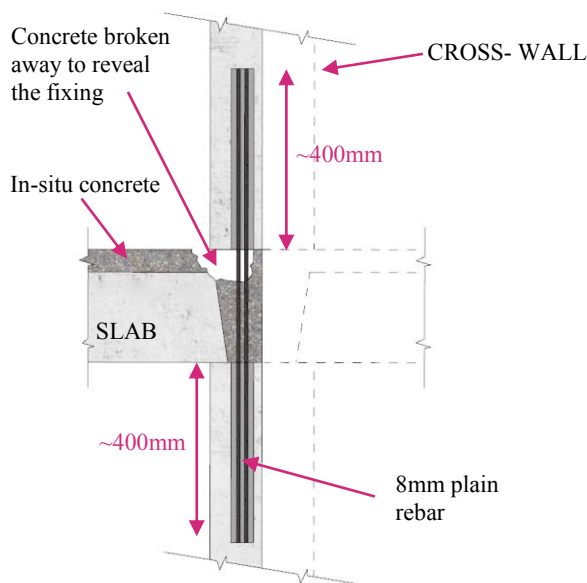
Only one joint was exposed, at location 13 (Figure 4), two 8mm plain vertical bars extending down into the in-situ concrete joint were found. It is unknown if the two bars extend the full height of the joint or if the bars are lapped.

Figure 14 Cross-wall to cross-wall vertical fixing. Only one side of the cross-wall was investigated

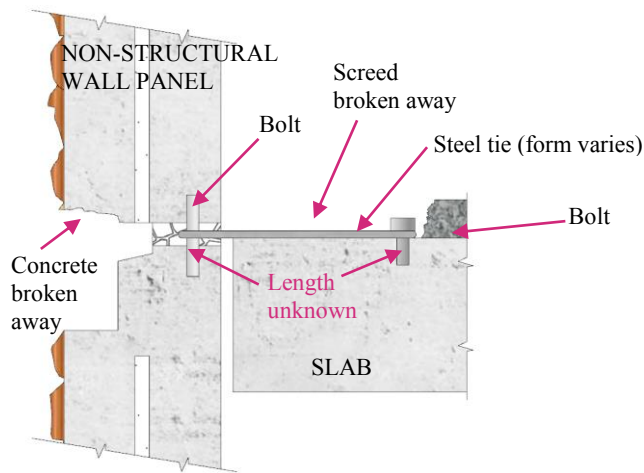
The non-structural wall panels are stacked upon each other and were not originally designed to carry vertical load, other than self-weight. They are tied back to the floor slabs with two ties per panel. Electromagnetic scans were used to locate the fixing details and two fixings (at locations 4 and 5 - Figure 4) were exposed. Different details were found at each locations (Figure 16), however the general principle is the same; the ties loop around a bolt (connecting adjacent non-structural wall panels) and are restrained via bolts to the top of the slab. The floor screed was broken away to reveal the ties from the inside and concrete was also broken away to reveal the bolt from the outside (Figure 15).

Figure 15 Non-structural wall panel to slab fixing

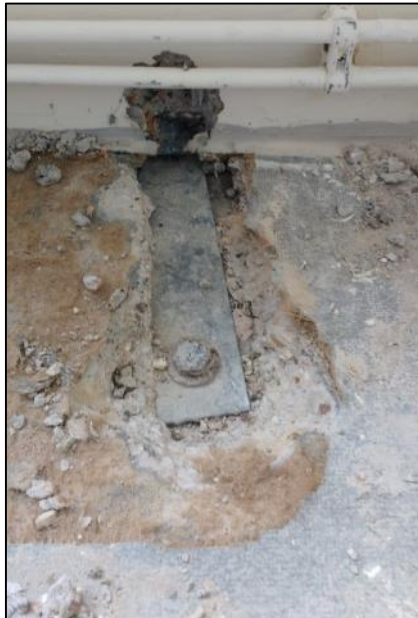
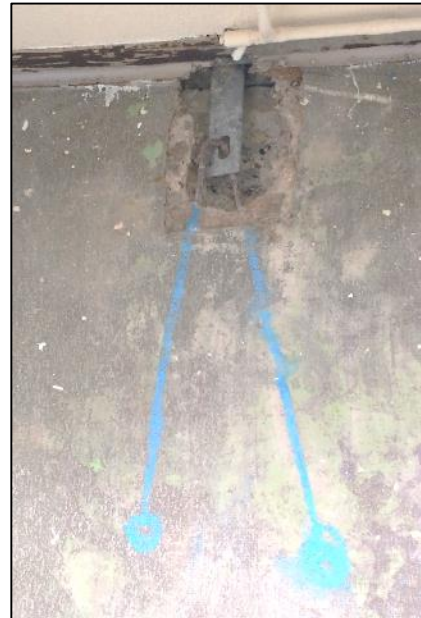
Figure 16 Non-structural wall panel to floor slab fixings exposed at locations 4 (LHS) and 5 (RHS). Chalk outline shows what the electromagnetic scanner located

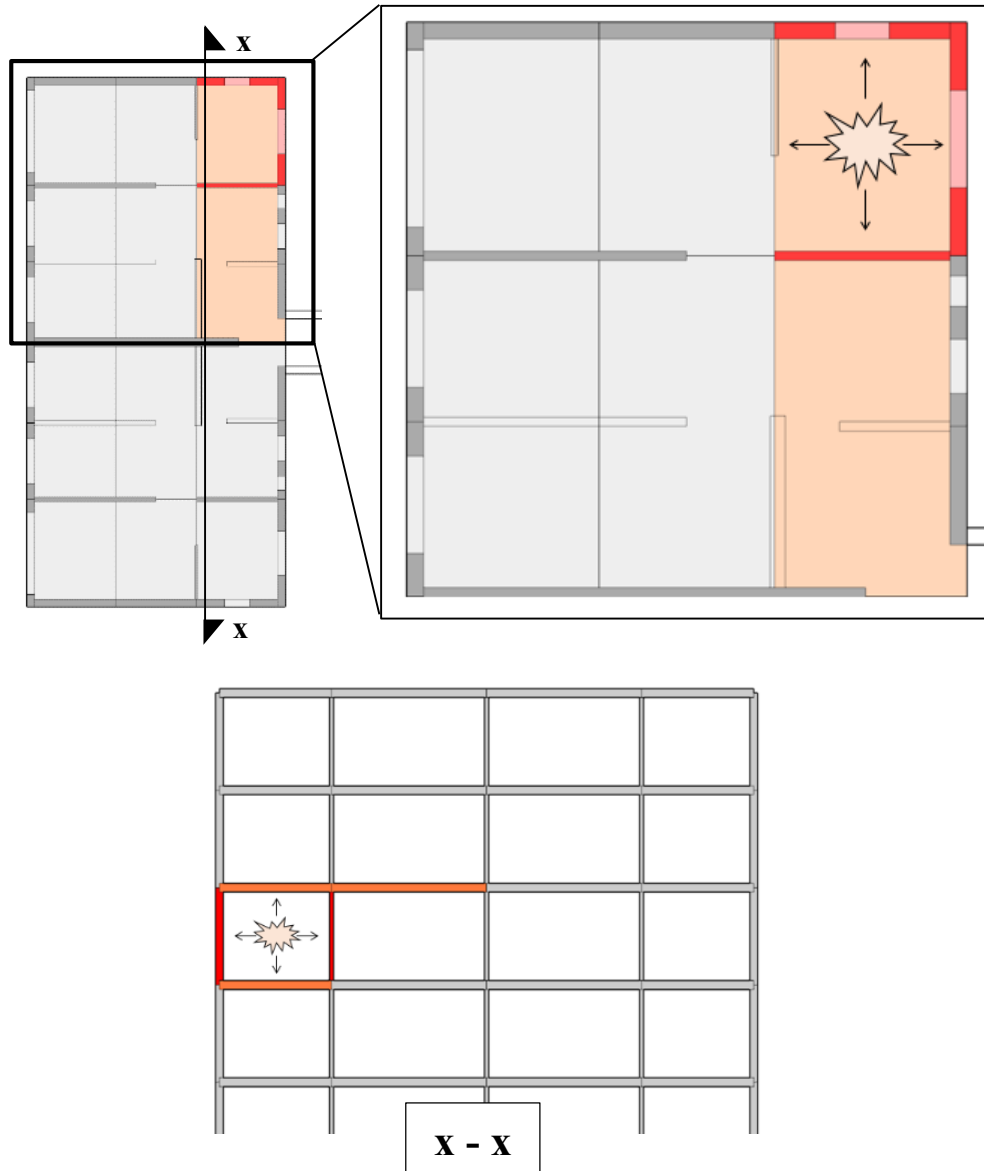
Our investigations indicate that the flank and cross-walls are unreinforced concrete. As such the walls do not have sufficient capacity to resist 34kPa (accidental load requirement for a block with piped gas) or 17kPa (accidental load requirement for a block with bottled gas) and as such the walls surrounding the explosion will fail. This has consequences to the floor immediately above which relies on the walls for support.

There is likely to be significant damage to the floor slabs in the room where the explosion occurs. The walls and floors that that would be affected by an explosion in the kitchen can be seen in Figure 17.

Figure 17 Plan view (above) and section view (below). The walls affected by an explosion occurring in the kitchen are highlighted in red. The affected floor slabs are highlighted in orange.

It is recommended that piped gas is turned off from the tower blocks on Ledbury Estate. Note: at the time of finalising this report, the gas has already been turned off. Based on the findings of the investigations undertaken, it would be impractical to strengthen the building to accommodate piped gas. The assessment also shows that the wall panels would fail under blast pressures defined by BRE [2] for non-piped gas. It is therefore recommended that gas is not re-introduced in any form. It is further recommended that the gas pipes be removed, to ensure there will be no future use of piped gas.

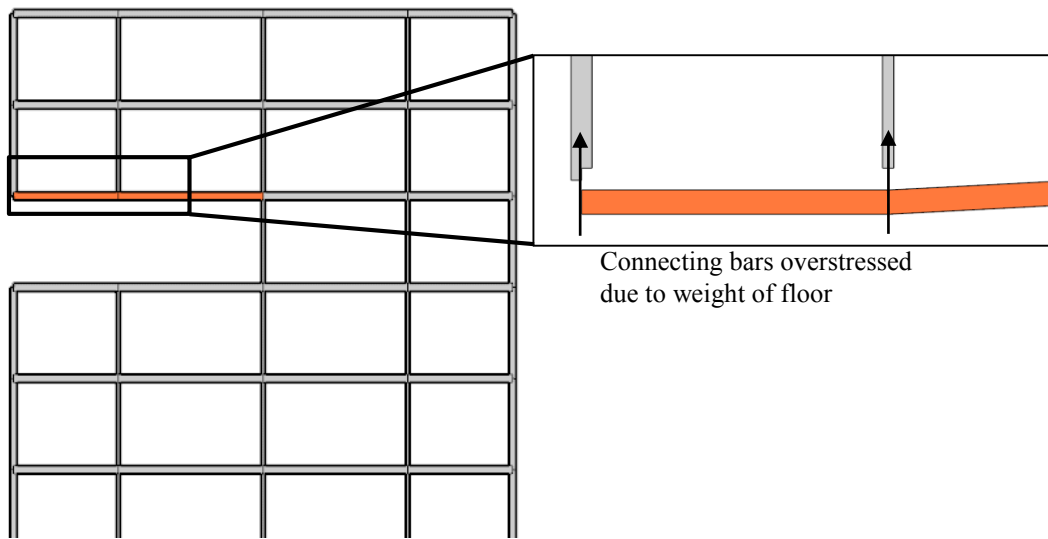
With the loss of the flank wall and the first internal wall, the floor on the level above the explosion will no longer have support from below and will try to vertically suspend from the wall above. Our investigations indicate that the floor slabs are connected to the wall below but are not directly connected to each other or to the wall above. Our investigations indicate that there are only two vertical bars per wall panel which continue from the wall panel to the wall panel above. The vertical bars are not capable of supporting the weight of the slab in tension and as such in the event of the wall failing below, then the floor previously supported by that wall would also collapse, see Figure 18. The area of the floor that would fail is greater than 15% of the total floor area (at that level) which is not compliant with the regulations for disproportionate collapse, see Figure 19.

Figure 18 With the loss of the flank wall and the first internal wall, the floor on the level above the explosion will no longer have support from below and will try to vertically suspend from the wall above. The connecting steel reinforcement bar would become overstressed due to the weight of the floor, leading to the tensile failure of this connection.

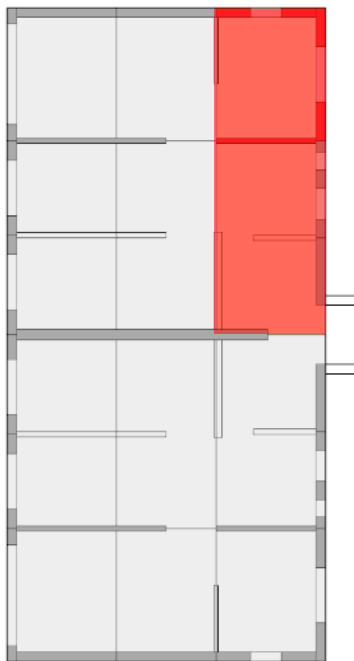
Figure 19 The area of the floor that would fail (highlighted in red) is greater than 15% of the total floor area (at that level)

Therefore, as described above, in the event of a gas explosion the walls are not able to resist the blast load of 34kPa (for piped gas) or 17kPa (for bottled gas) and therefore would fail the LPS Criterion 2 (as defined by BRE [2]). With the flank wall and/or the first internal wall removed, the floor slabs of the level above are not adequately tied to the walls above or to each other and thus there is no reliable alternative path of support and therefore cannot be shown to meet LPS Criterion 3 (as defined by BRE [2]).
