# Clean effluent

## The challenge

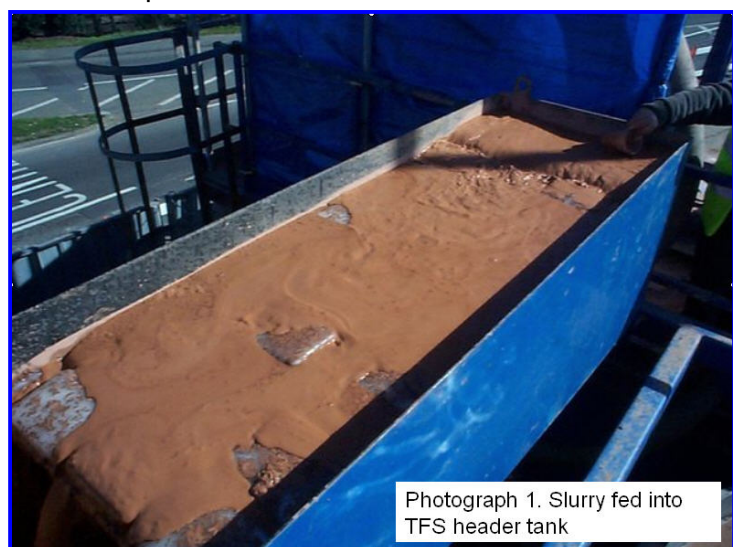
Photograph 1. Slurry fed into TFS header tank

allowing further discharges. Photograph 1 above demonstrates the quality of slurry being fed into the TFS.

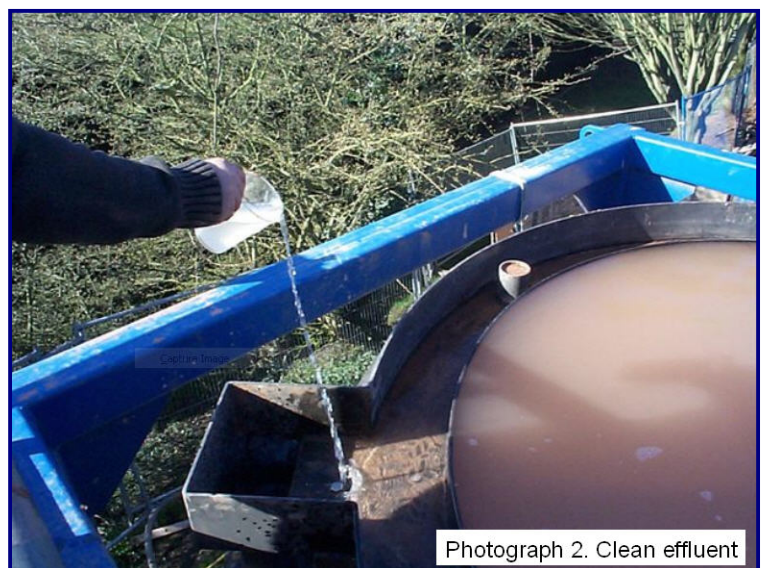
Photograph 2. Clean effluent

**In the end a clean effluent was generated which was acceptable for disposal to the available foul sewer (see picture 2).**
