# TEMPLE AVENUE PROJECT UNPUBLISHED DRAFT 06.06.2012

ENVIRONMENTALLY SUSTAINABLE REFURBISHED HOMES  
FOR THE 21ST CENTURY

## INTRODUCTION TO THE 67 PROJECT

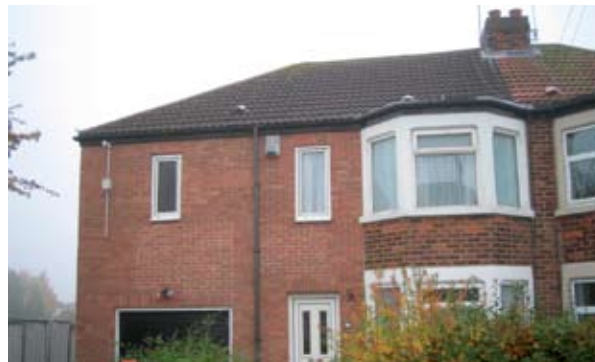
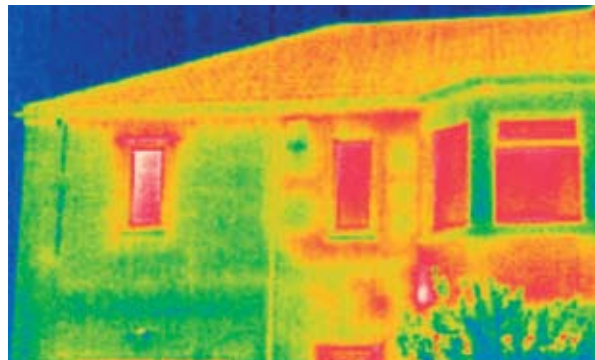
Thermogram showing air and heat leakage through the existing uninsulated walls and windows

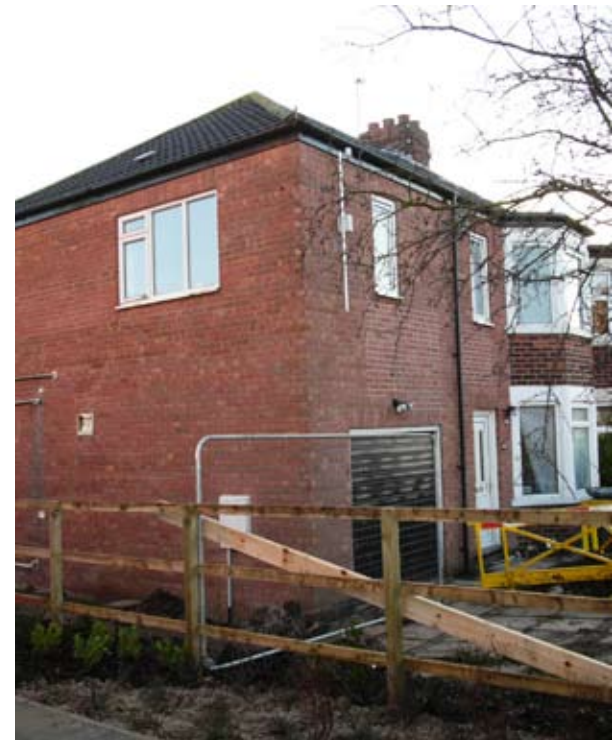
1. CWI added to all external walls and original side wall
2. Top of cavities packed with insulation to reduce thermal bypass
3. 75 mm rigid insulation lining to semi-external walls and first floor around integral garage
4. Service penetrations through external walls removed/ sealed
5. 400 mm insulation (100 mm between ceiling joists, 300 mm above) in the main loft
6. Insulation between bay window rafters
7. 75 mm rigid insulation below rafters in rear extension roof
8. Ground floor sealed with taped hardboard
9. Chimney blocked and insulated
10. Boiler, hot water cylinder and related plumbing moved inside the thermal envelope

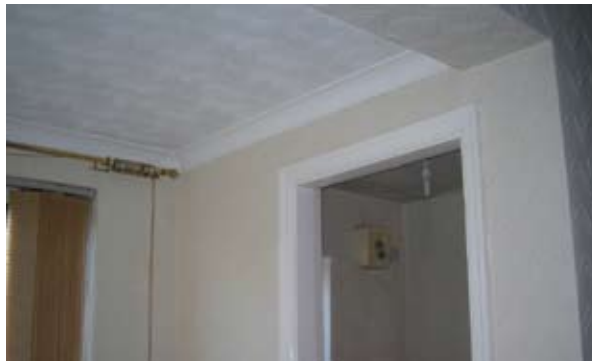
Blown-in cavity wall insulation (CWI) was installed by an approved contractor who had carried out many similar installations over a number of years. However, thermograms showed that in some areas the installation had had very little effect on the thermal conductivity of the external walls, and had certainly not reduced it by the 73 per cent assumed in the design calculations.

"The CWI retro-filling of the brick-brick external walls was predicted to bring the U-value down from 1.68 W/m<sup>2</sup>K to 0.45 W/m<sup>2</sup>K, yet even after filling the measured U-values varied from a highest value of 1.93 W/m<sup>2</sup>K to a lowest of 0.70 W/m<sup>2</sup>K" (Miles-Shenton et al. 2012, p. 58).

Even though established industry procedures were followed carefully, the level of fill of cavity wall insulation was found to be very uneven throughout the dwelling with a number of areas having little, if any, insulation present.

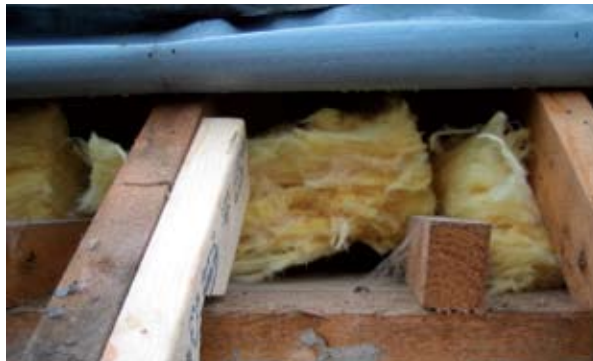
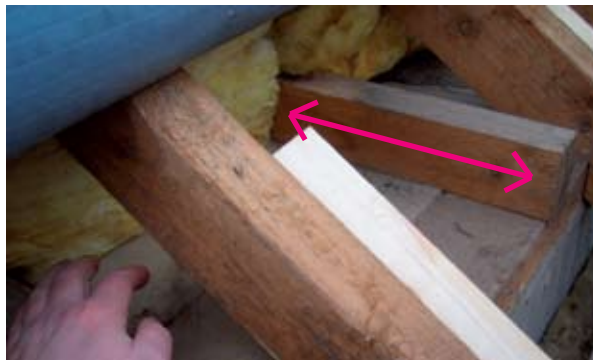
Opposite. Thermogram of rear extension showing significant cold bridging at the eaves

Gap (shown by arrow) between the CWI and roof insulation at the eaves discovered when the tiles were lifted during the second stage of works

Lifting the roof tiles at the eaves during the second stage of works revealed a gap between the CWI and roof insulation, compromising the continuous thermal barrier. It was also found that the insulation packing at the top of the cavities, proposed in order to reduce thermal bypass, had been omitted.

The thermogram overleaf suggests that there could be a gap between the cavity and roof insulation. However, what thermographic inspections cannot reveal is the extent of heat loss through the uninsulated ground floor.

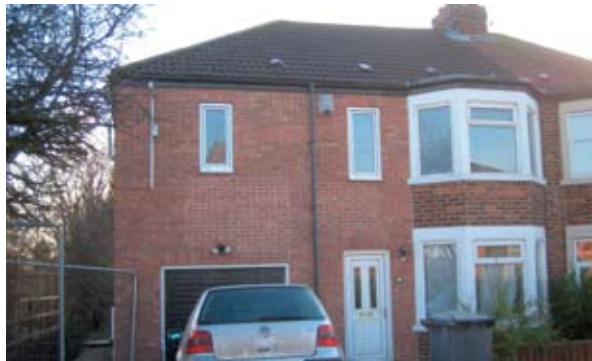
The measured airtightness of  $9.83 \text{ m}^3/(\text{h}\cdot\text{m}^2)\text{@}50\text{Pa}$  is a reasonable improvement on the existing house airtightness of around  $16 \text{ m}^3/(\text{h}\cdot\text{m}^2)\text{@}50\text{Pa}$  and complied with current new build standards at the time of the works.

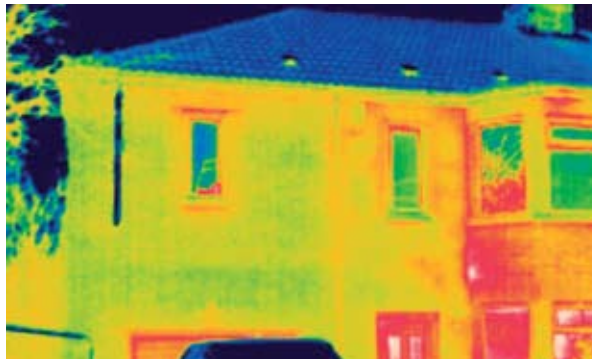
The thermogram to the left indicates that the CWI may not have entirely filled the cavity, or that the cavity is 'bridged'. The CWI was predicted to reduce the U-value of the external walls from  $1.68$  to  $0.45 \text{ W/m}^2\text{K}$ . Yet heat flux sensors measured U-values that varied from a highest value of  $1.93 \text{ W/m}^2\text{K}$  to a lowest value of  $0.70 \text{ W/m}^2\text{K}$ .

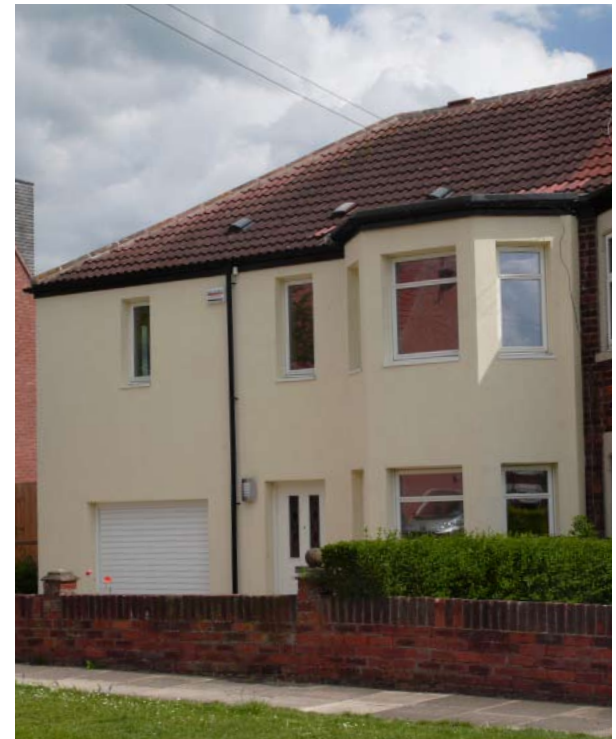
1. 175 mm EWI with render coating
2. Eaves extended and external water and waste pipes rerouted to accommodate EWI thickness
3. Existing concrete and timber ground floors removed and replaced with insulated concrete ground floor
4. New argon-filled, triple-glazed timber windows
5. New composite insulated external doors
6. MVHR (mechanical ventilation with heat recovery)
7. Airtightness improved as a result of solid ground floor; new windows; external wall insulation; and good workmanship
8. Solar hot water panels installed on the south side of the property

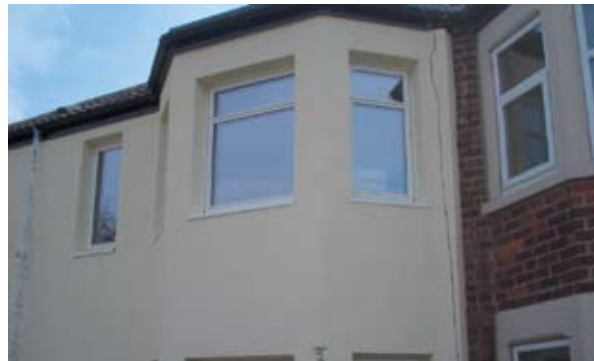
The final airtightness of  $5.42 \text{ m}^3/(\text{h}\cdot\text{m}^2)\text{@}50\text{Pa}$ , against a target of  $5 \text{ m}^3/(\text{h}\cdot\text{m}^2)\text{@}50\text{Pa}$ , was achieved with the dwelling not fully finished and some sealing still to be carried out.

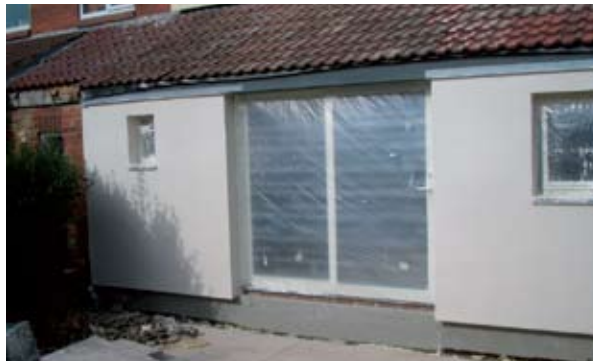
Opposite. Thermogram taken following external wall insulation installation

Thermogram following EWI installation showing heat loss (blue area) through the patio door threshold where the external step bridges the insulation

The EWI significantly improved thermal bridging, although the design value of  $0.15 \text{ W/m}^2\text{K}$  was not met and values of  $0.23\text{-}0.24 \text{ W/m}^2\text{K}$  were measured. Higher U-values were measured around openings suggesting thermal bypass heat losses as a result of air circulation in gaps behind the insulation. Thermal bypasses were also detected on the new build project 54 and 69. Minor discontinuities in the EWI were difficult to avoid around the existing entrance and patio doors.

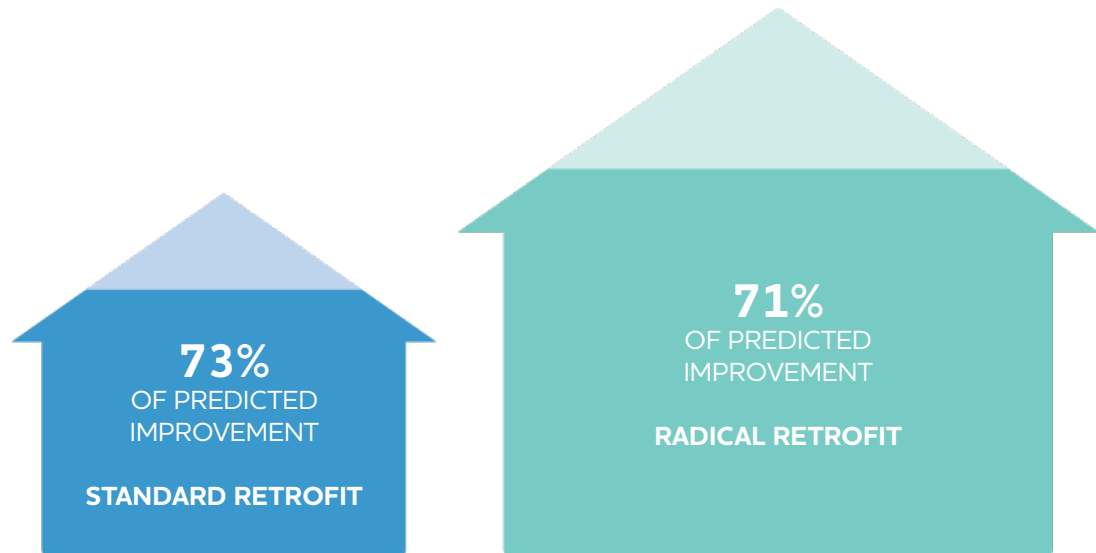
A comparison of measured (as-built) versus predicted (as-designed) heat loss uncovers inaccuracies in the estimations. The inputs to SAP underestimated the performance of the dwelling in its existing condition; and at higher levels of performance overestimated the benefits of the improvements taken.

condition were dependent on the accuracy of the initial survey and the standard assumptions made about the thermal performance of the construction. In this instance the initial investigation was conducted with minimal disruption to the then occupants. A more intrusive investigation could have led to a more accurate prediction.
