00 Piece by Piece - Library

Conservatio Creatio Aeterna Est / Introduction

Within the Piece by Piece document, we have chosen to examine the most significant room in the Glasgow School of Art; the Library. Often acknowledged as the most important form in all of Mackintosh's work, the Library was seen as the spiritual and intellectual heart of the Mackintosh building.

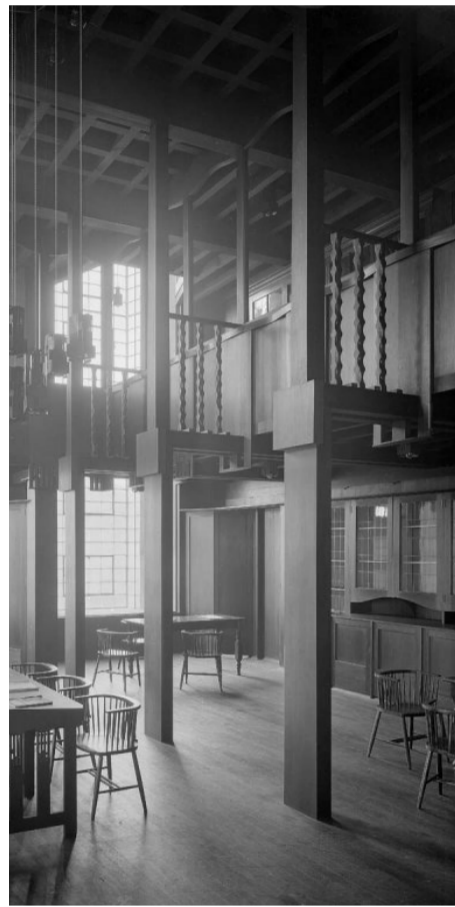
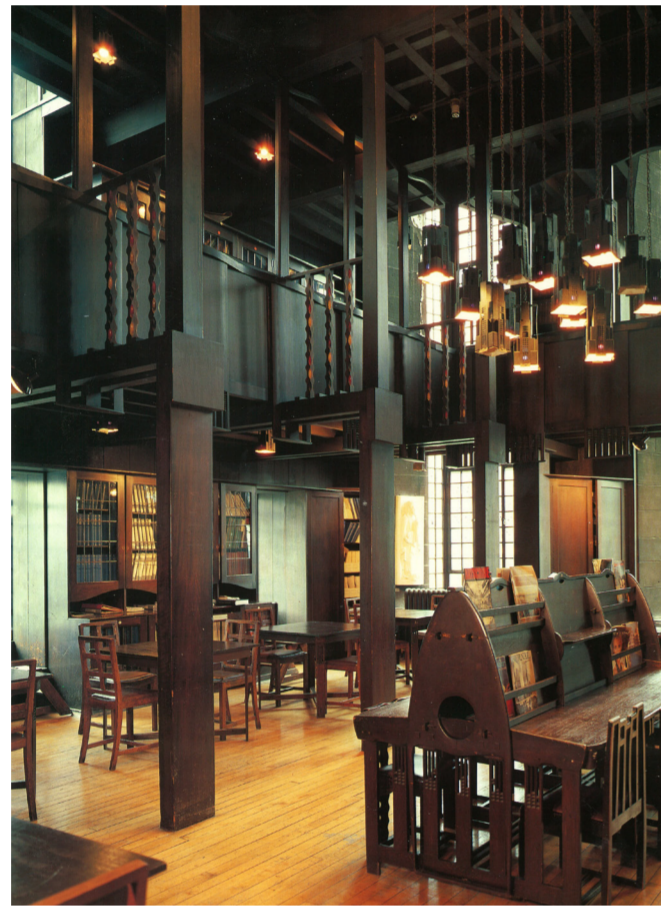
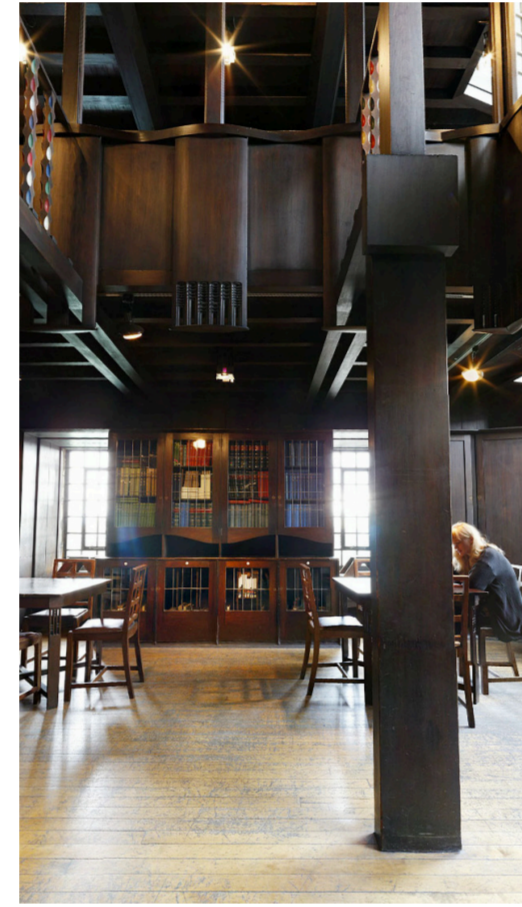
Photographic evidence

1. Photo by Henry Bedford Lemere, Library circa 1910 © RCAHMS
 2. Library pre-fire. Glasgow School of Art Collection.
 3. The Guardian, Library at Glasgow School of Art - 360 interactive panoramic.

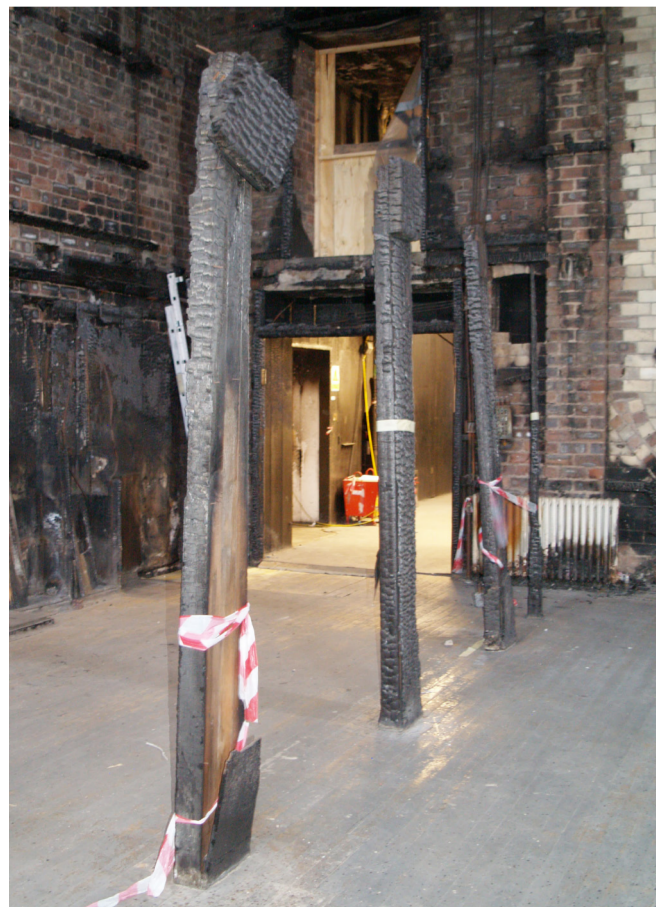
1. Timber post post-fire
 2. Upper post.
 3. Upper post comprised of two composed.
 4. Timber plate covering joints junction.
 5. Plan of the post and timber plate. Thick nails fixing lower and upper post highlighted in circle.

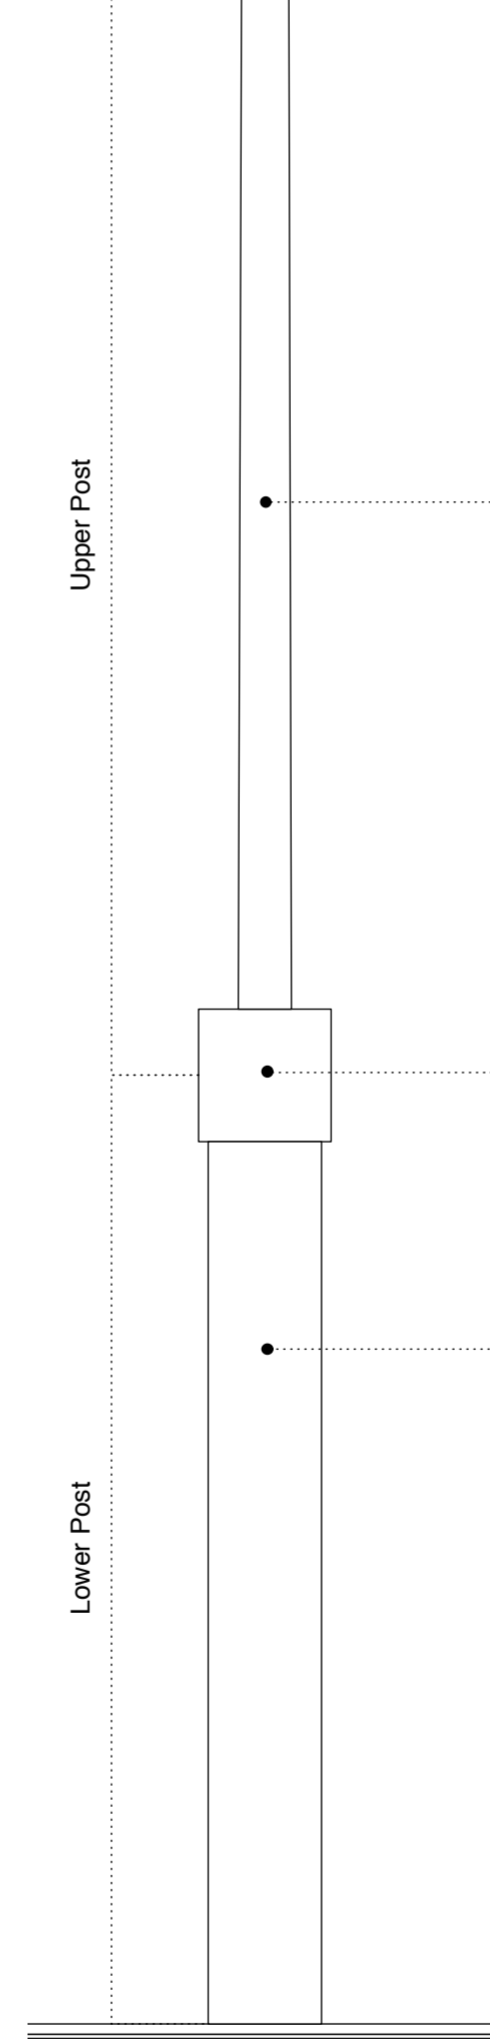
Front elevation of timber post
 Scale: 1:20

Upper timber post composed of one or two components tapering 0.15° . Refer to drawing 3 opposite.

Timber plate covers joist ends. Refer to drawing 2 opposite.

Lower timber post composed of five components. Refer to drawing 1 opposite.

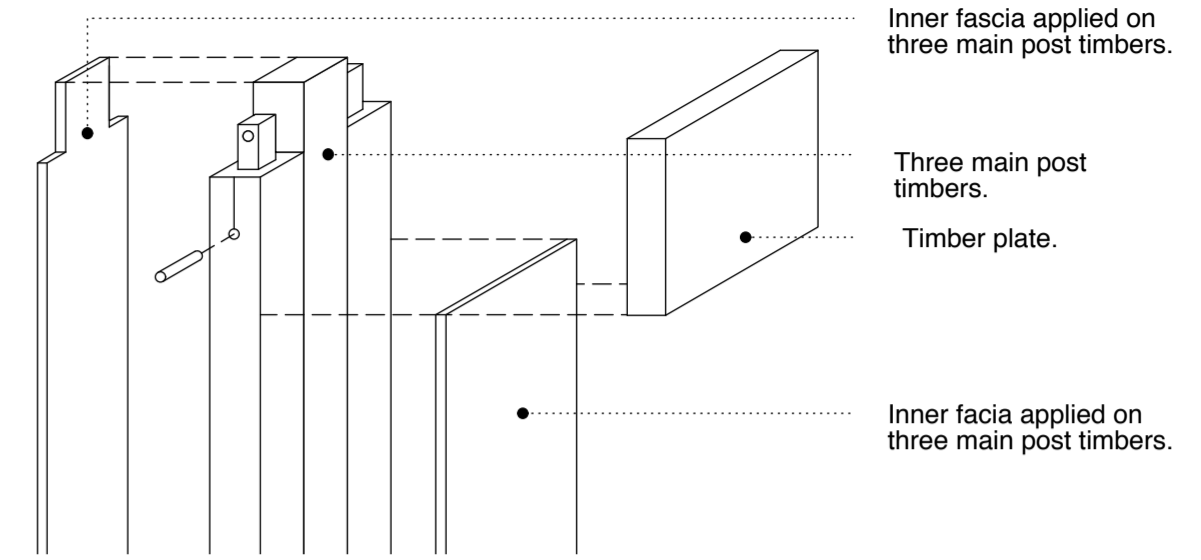
4 Isometric presenting elements of lower post
 Scale: 1:15

Inner fascia applied on three main post timbers.

Three main post timbers.

Timber plate.

Our examination of the lower post revealed that it was in fact composed of five separate elements: three middle timbers and inner and outer fascias applied with rows of nails. The structure rests on a steel beam and is held in place by floor joists. Two outer joists are shorter than the middle one and are fixed by a tenon joint to the two balustrade beams running across to the wall socket. The balustrade beams are notched to accommodate the foot of the upper post that is composed of two components. The post is then fixed to the steel beams, bearing the weight of the floor of the former bookstore above the library. Square timber plate covers the joints in between the posts and balcony beams.

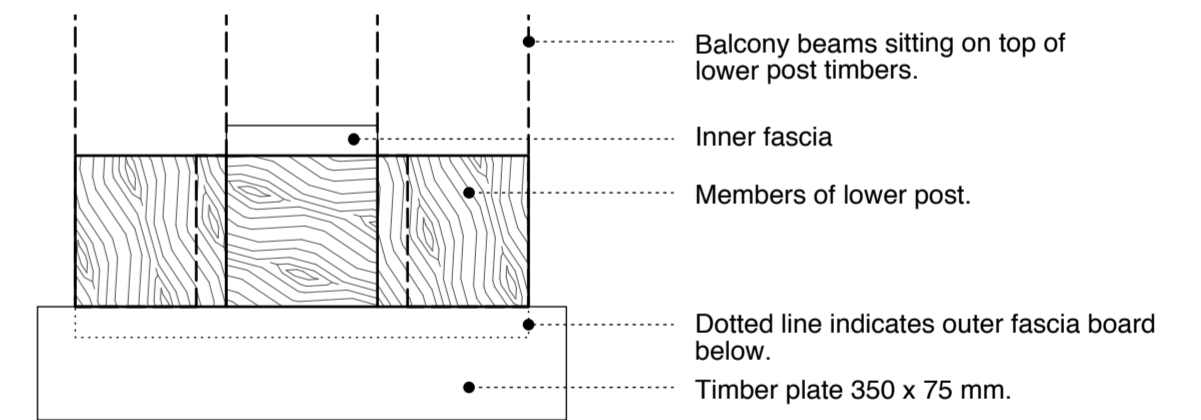
2 Plan of plate
 Scale: 1:5

Dotted line indicates outer fascia board below.
 Timber plate 350 x 75 mm.

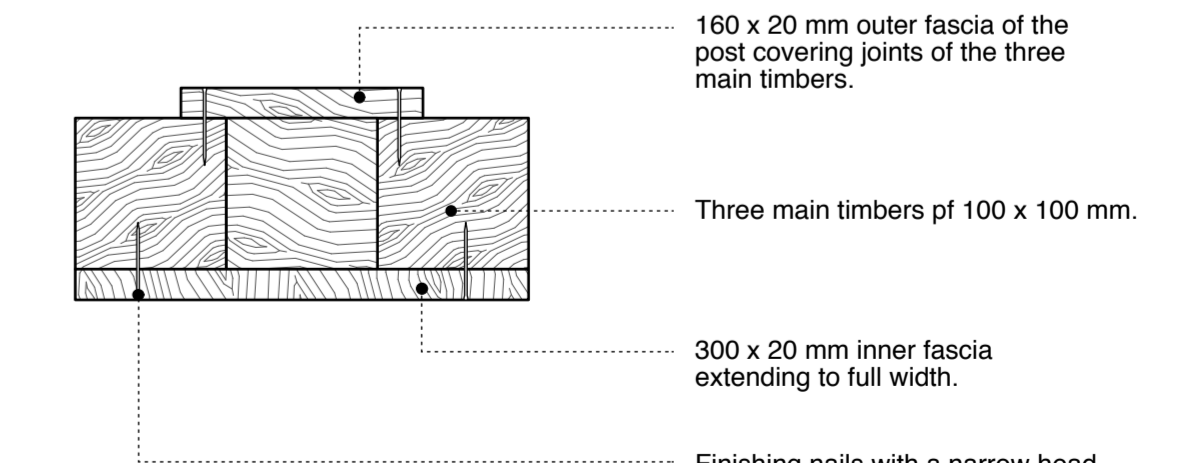
1 Plan of lower post
 Scale: 1:5

Balcony beams sitting on top of lower post timbers.

Inner fascia
 Members of lower post.

160 x 20 mm outer fascia of the post covering joints of the three main timbers.

Three main timbers pf 100 x 100 mm.

300 x 20 mm inner fascia extending to full width.

Finishing nails with a narrow head. Heads slightly punched into surface of fascia with holes filled.

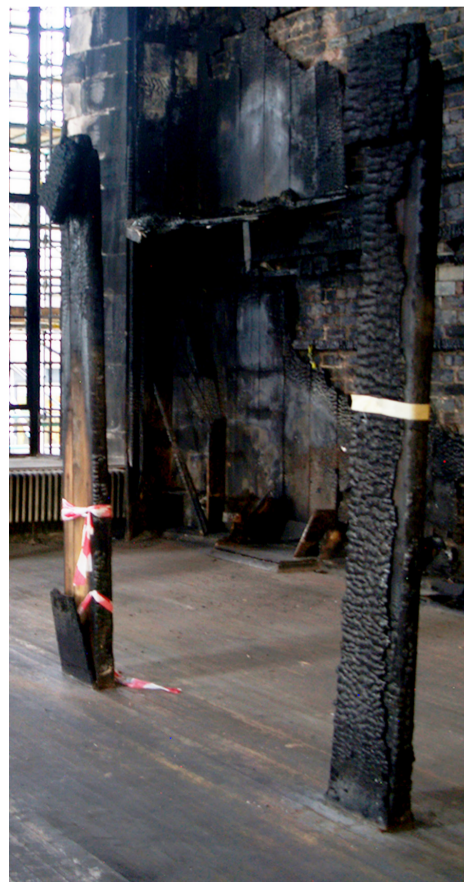
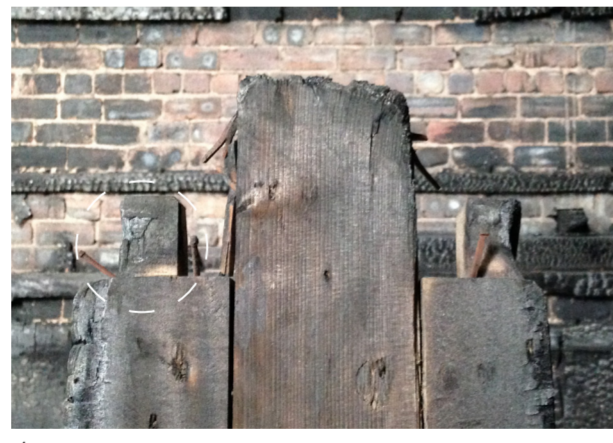
1. Timber post post-fire.
2. Outer elevation of the lower post and remaining end of the balustrade beam. Remain of tenon joint highlighted with circle.
3. Inner elevation of the lower post. Remain of tenon joint highlighted with circle.
4. Tenon joists secured with nails driven vertically highlighted in circle.
5. Base components of the lower post.

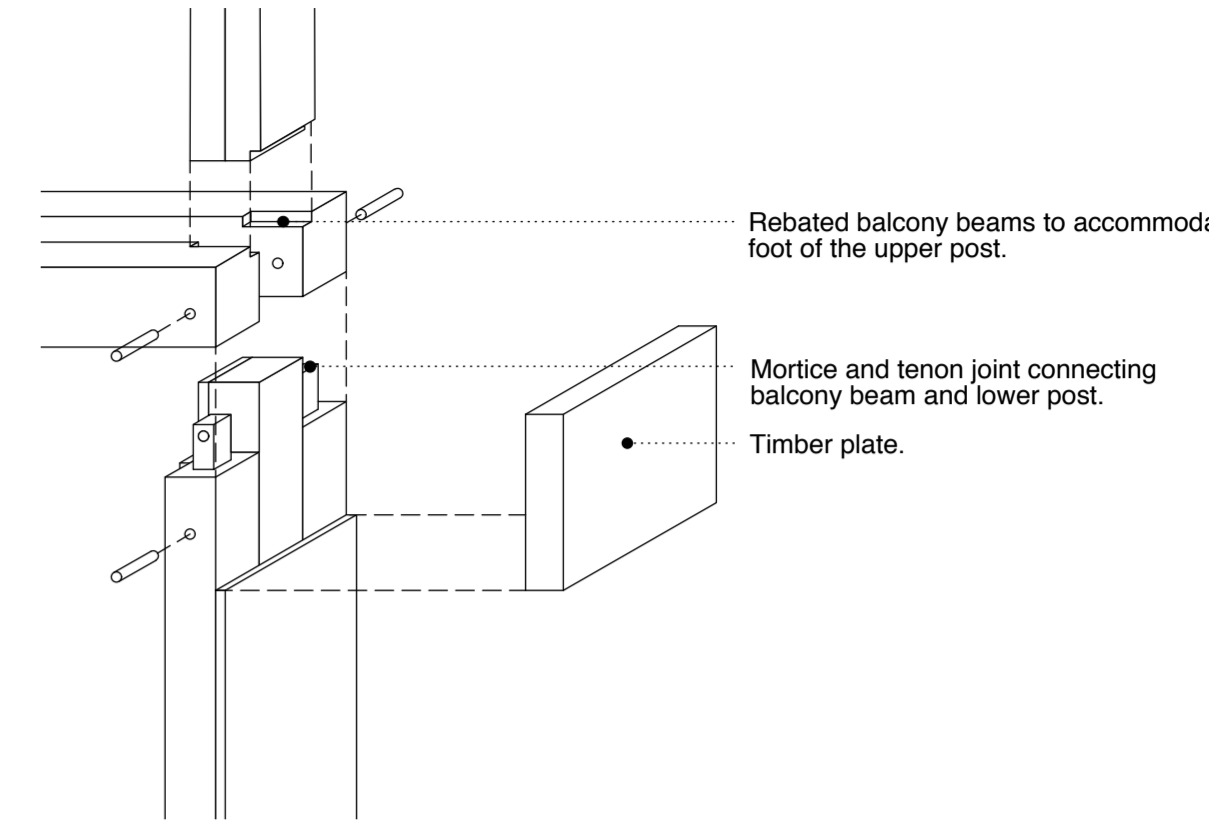
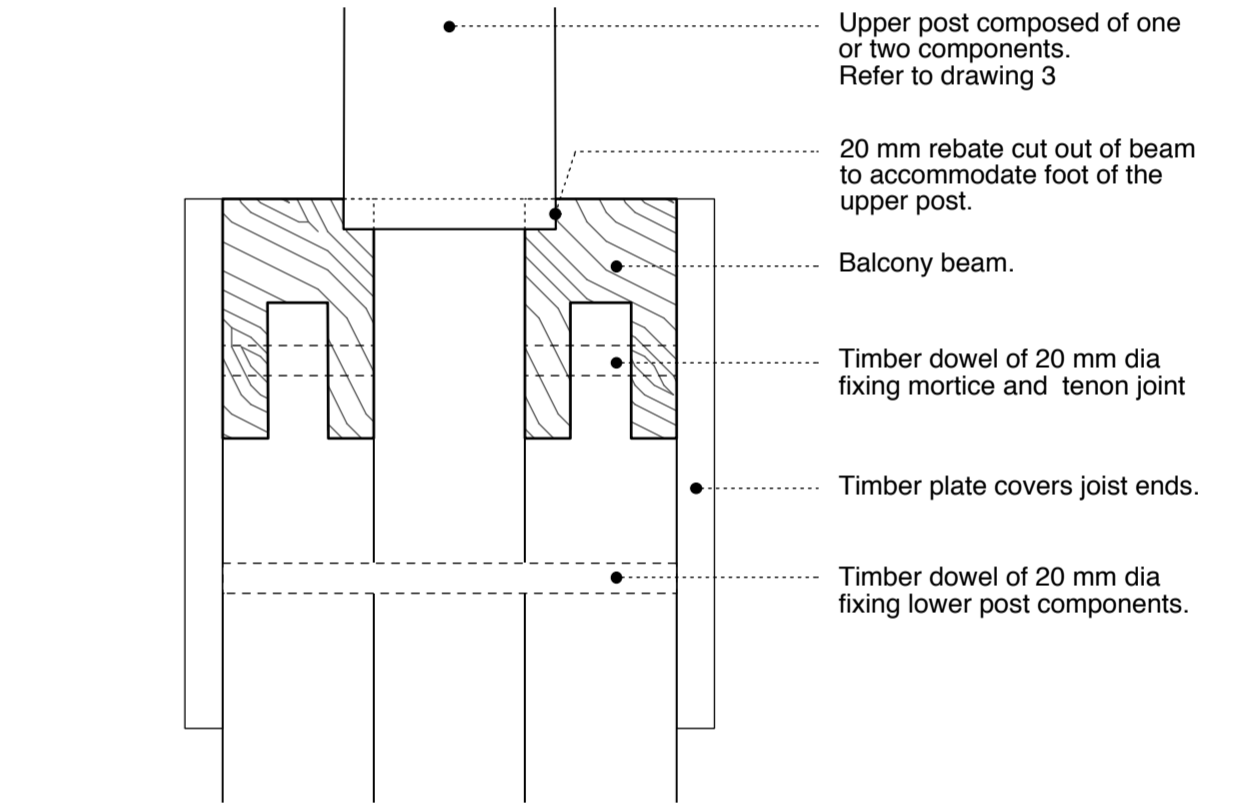
6 Section through timber post. Scale: 1:5

7 Axonometric presenting timbers build up. Scale: 1:15

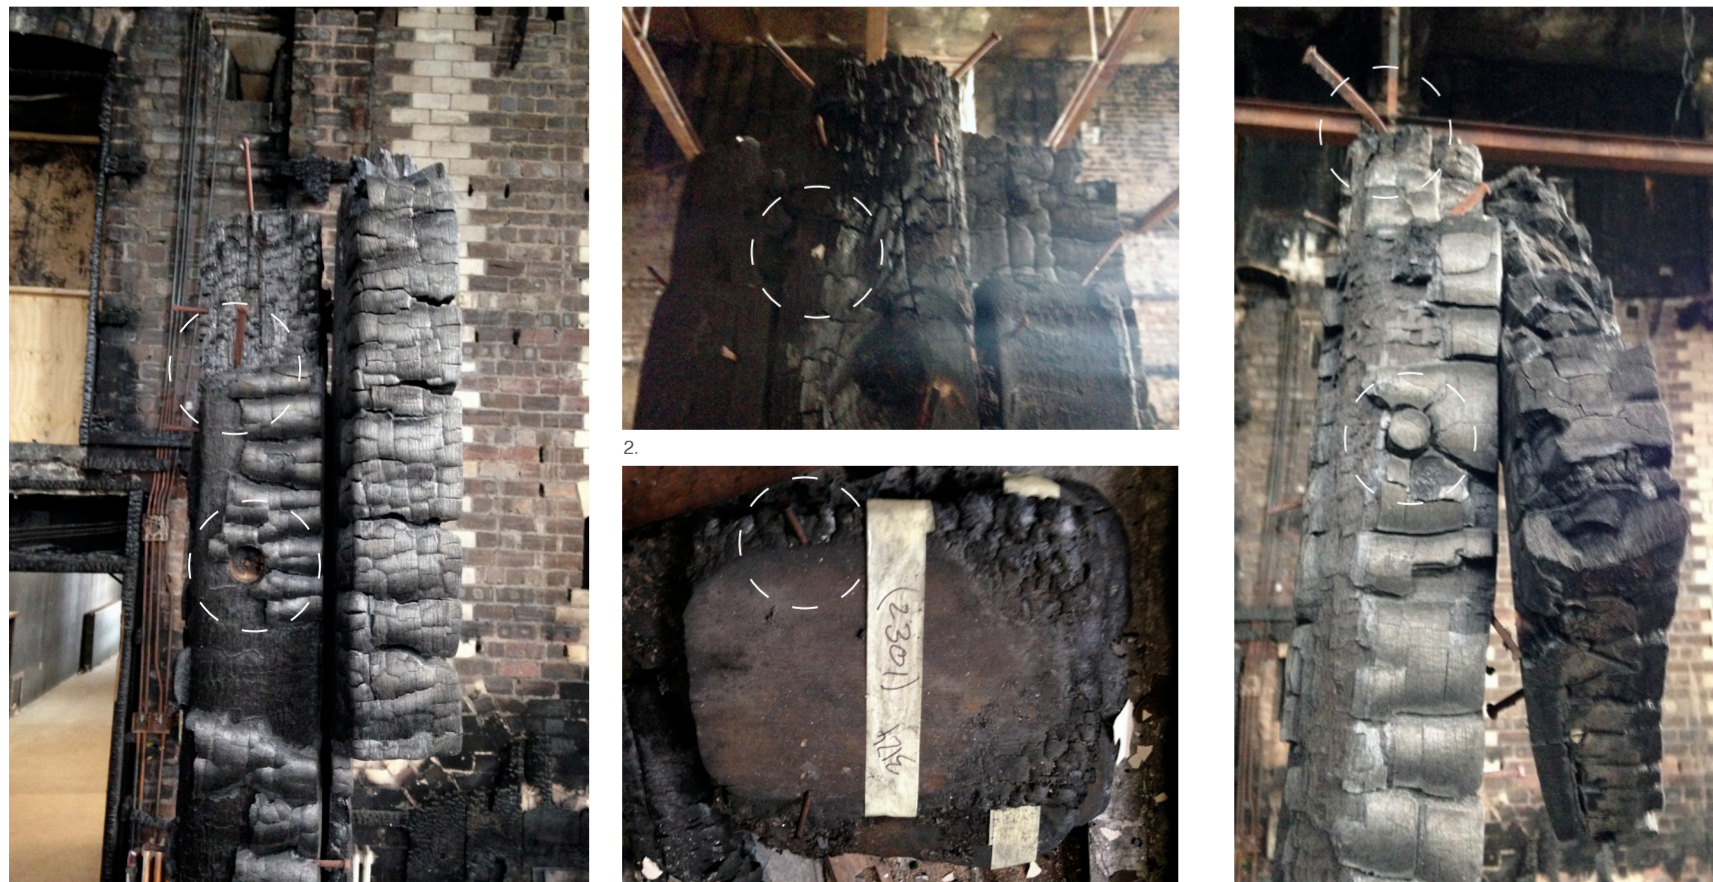
1. Side elevation of the lower post and timber plate.
 2. Outer elevation of the lower post. Nails outer fascia highlighted.
 3. Back elevation on timber plate. Screws driven with an angle securing the plate highlighted.
 4. Side elevation of the lower post. Timber dowel and nail securing the upper post highlighted.

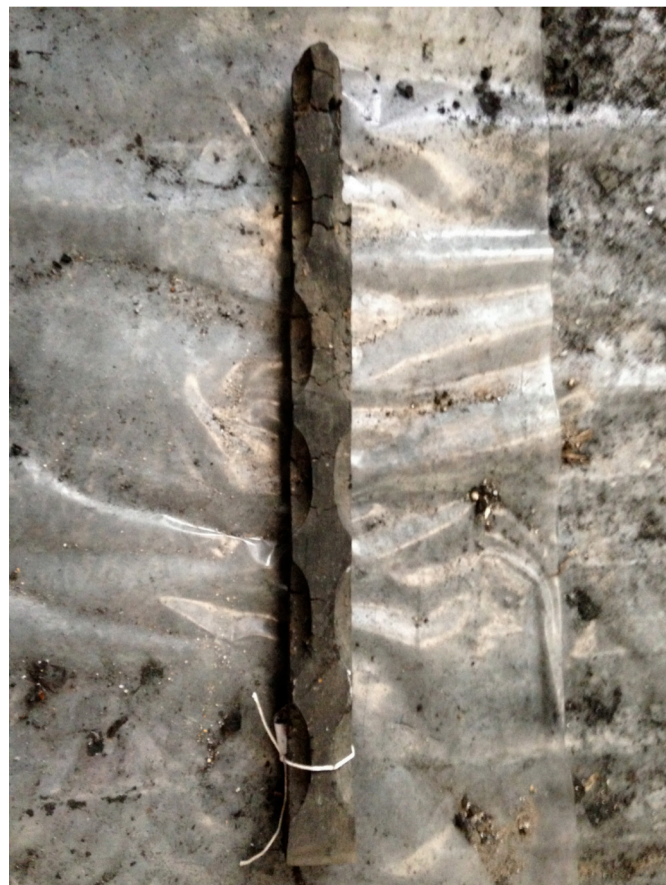
1. Timber balustrade post post-fire.
 2. Design for the staircase screen, 78 Derrigate, Northampton. Hunterian Art gallery Mackintosh Collections ref: GLAHA 41104. An example of the evolving geometrical style of Mackintosh.

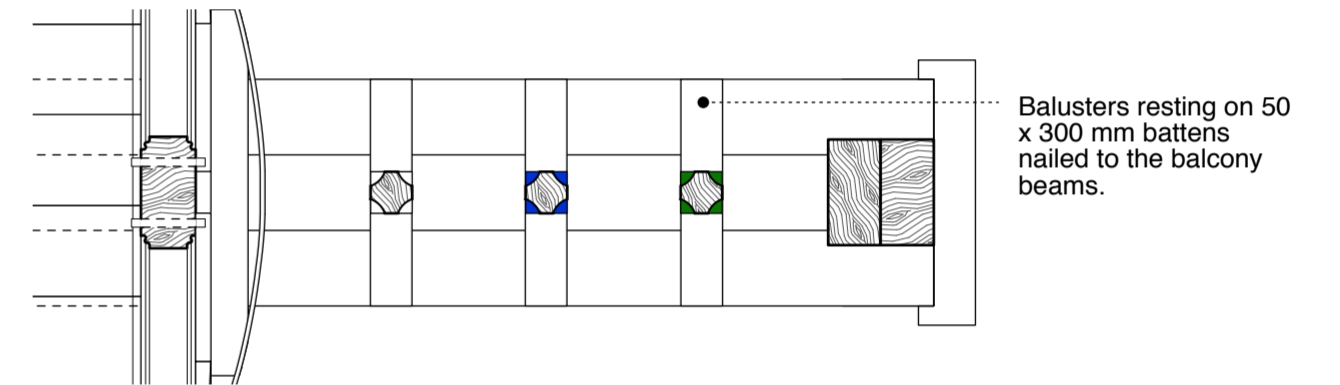
12 Balustrade and Balcony Plan
 Scale: 1:10

Balusters resting on 50 x 300 mm battens nailed to the balcony beams.

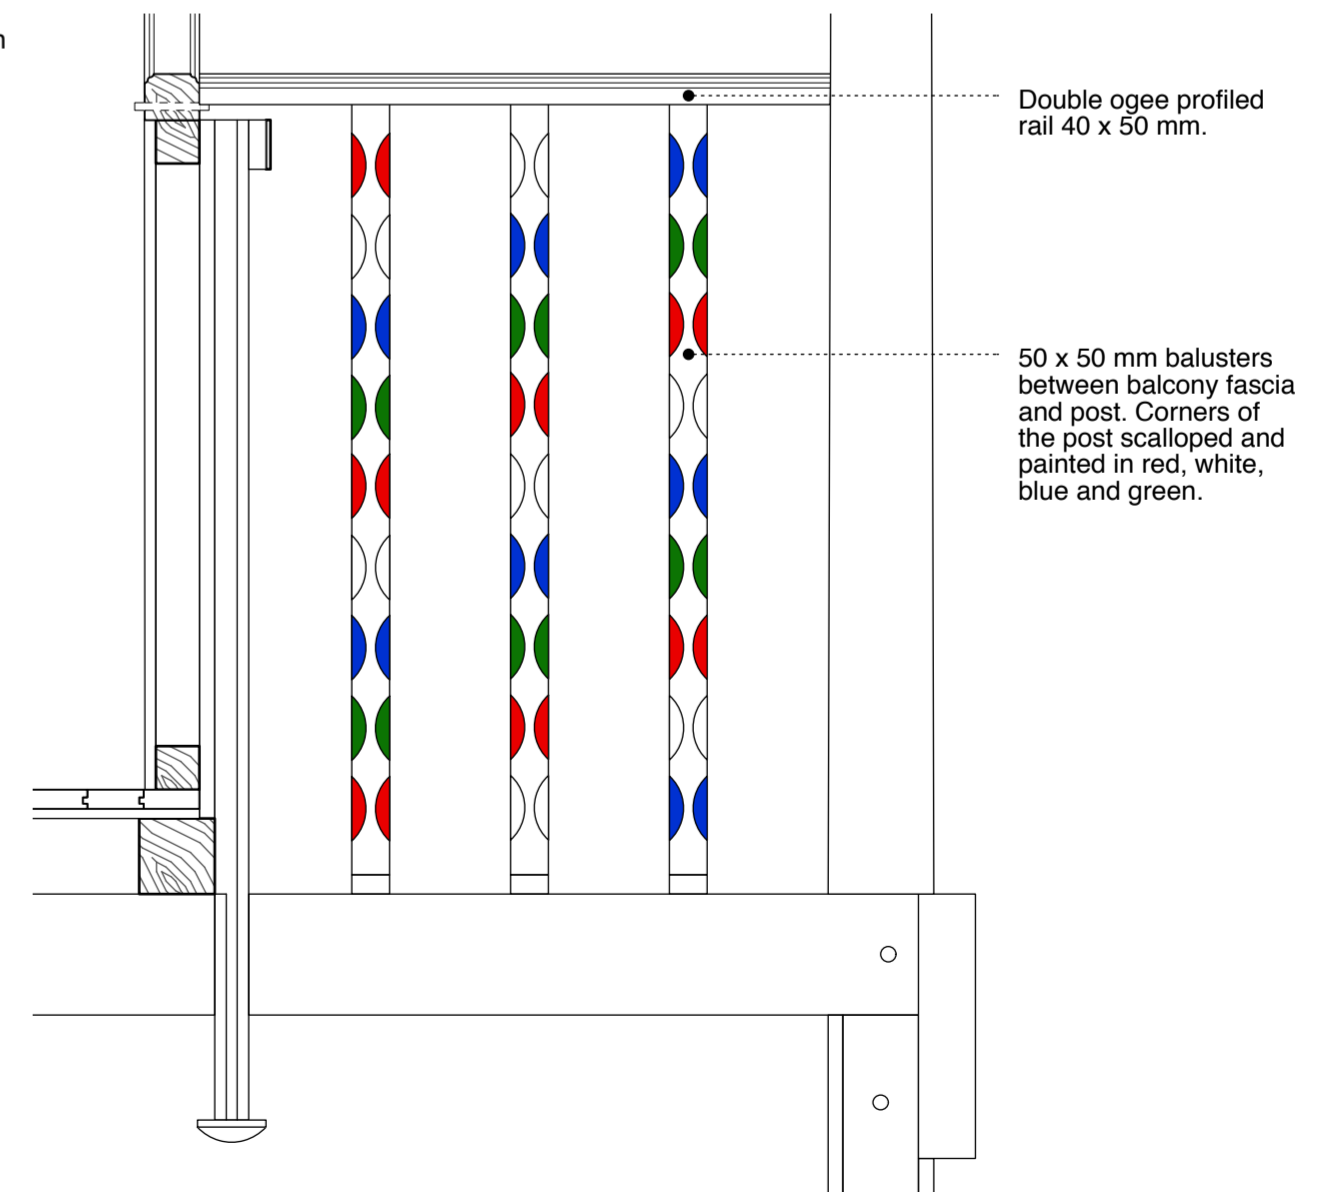
11 Side elevation of the balustrade
 Scale: 1:10

Double ogee profiled rail 40 x 50 mm.

50 x 50 mm balusters between balcony fascia and post. Corners of the post scalloped and painted in red, white, blue and green.

Position of balustrade post on balcony beams.

Inner fascia.

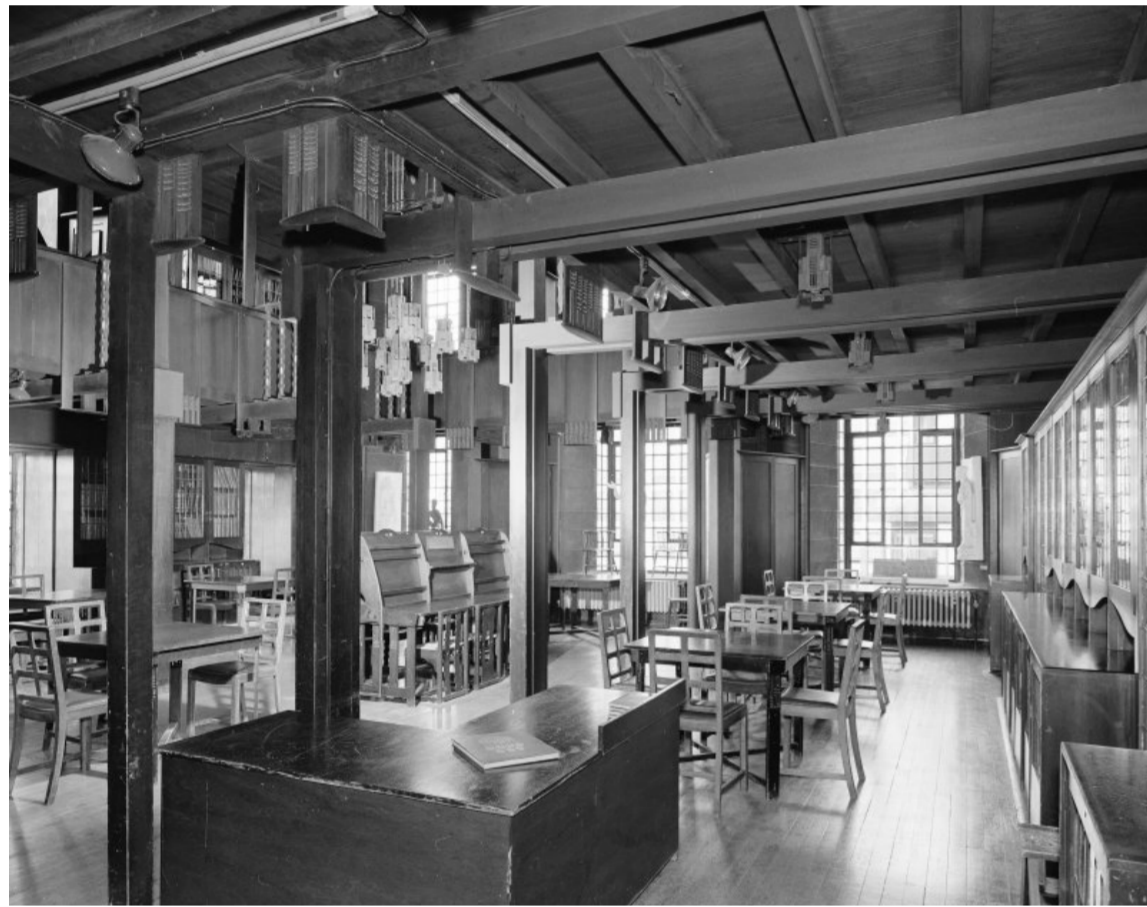
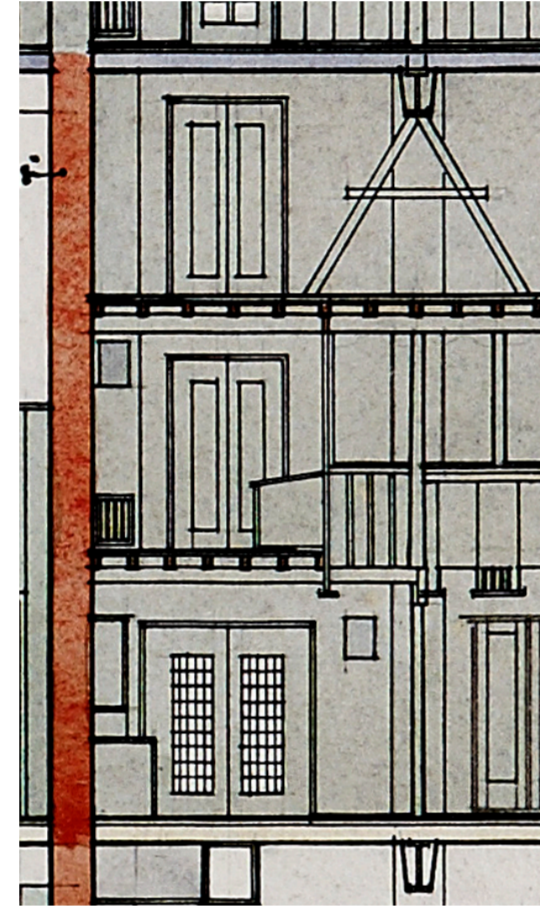
1. Underside of the Balcony showing the balcony beam and balcony floor joists.
 © RCAHMS
 2. Section D-D through Library, balcony and furniture store 1910. Glasgow School of Art Collection.

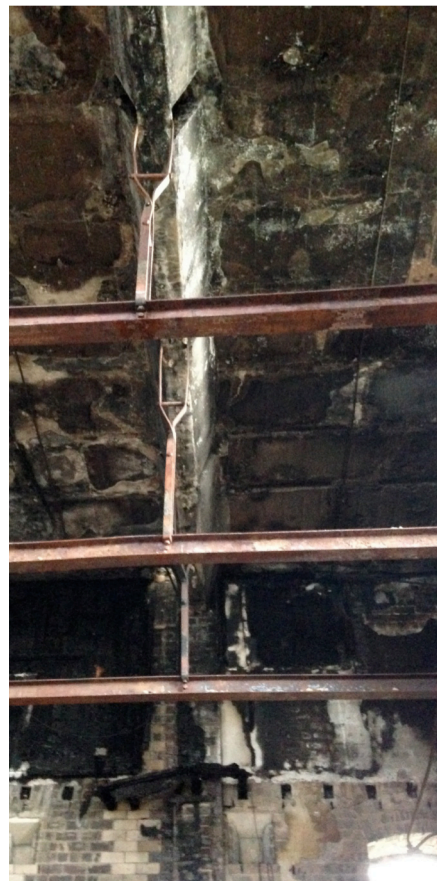
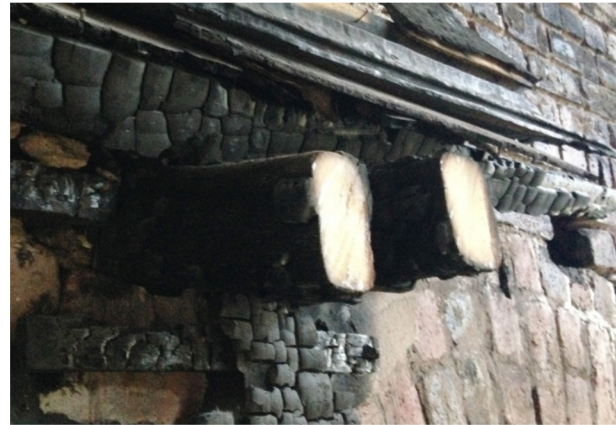
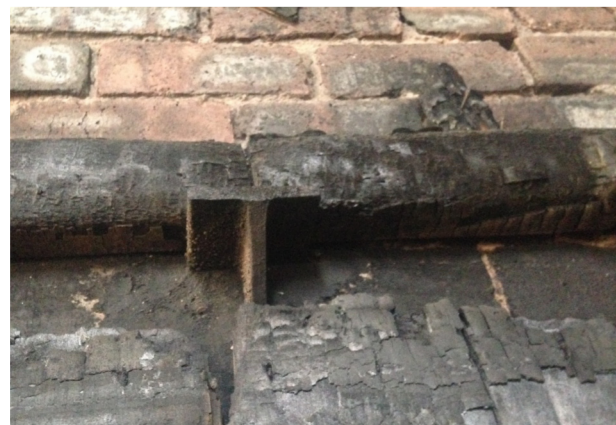
1. Steel straps tying I-beams to the Library ceiling with beams to the former bookstore. Upper posts were positioned directly below straps prior to fire.
 2. Remains of balustrade joists embedded into the wall.
 3. Steel T-bearers supporting timber beams running horizontally and balcony floor joists.
 4. Steel T-bearer and remains of timber panels below.
 5. Remains of timber panels fixed to battens.

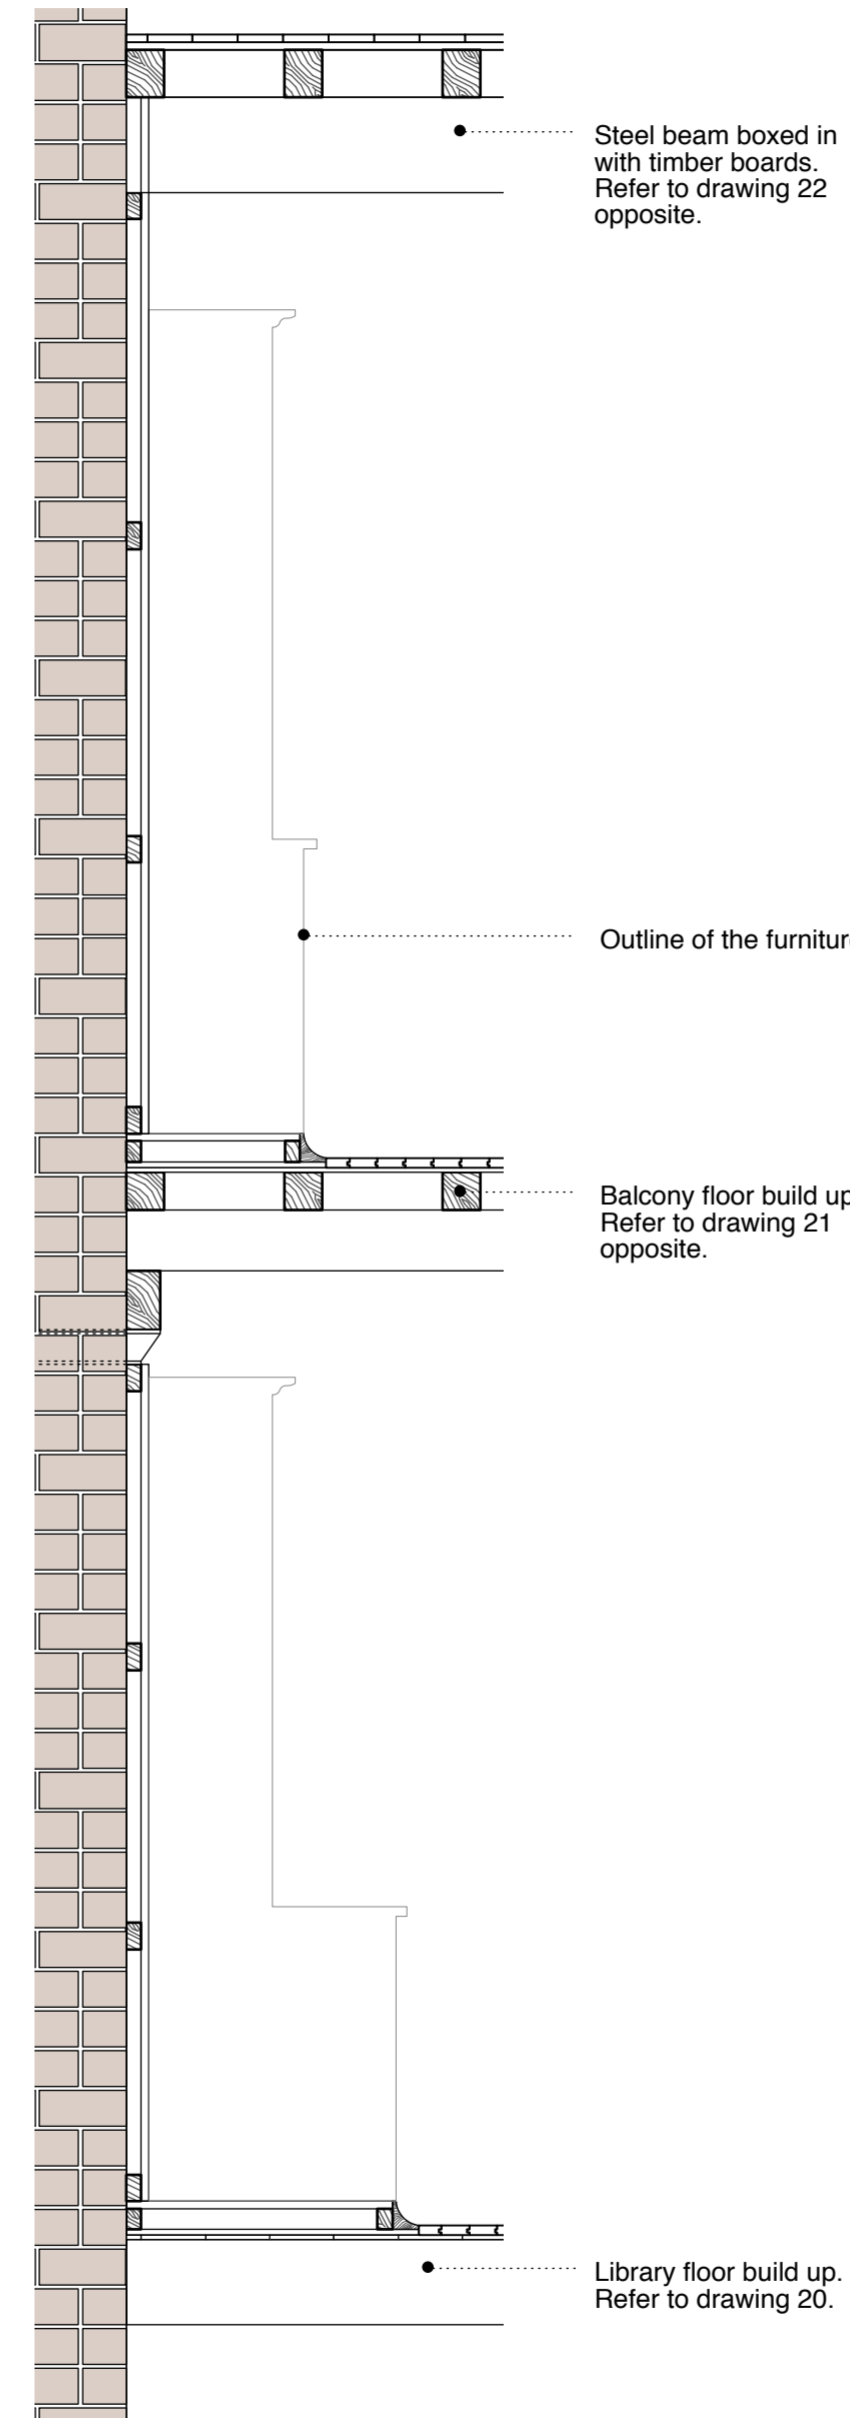
Section through west wall of the Library
 Scale: 1:20

Steel beam boxed in with timber boards. Refer to drawing 22 opposite.

Outline of the furniture.

Balcony floor build up. Refer to drawing 21 opposite.

Library floor build up. Refer to drawing 20.

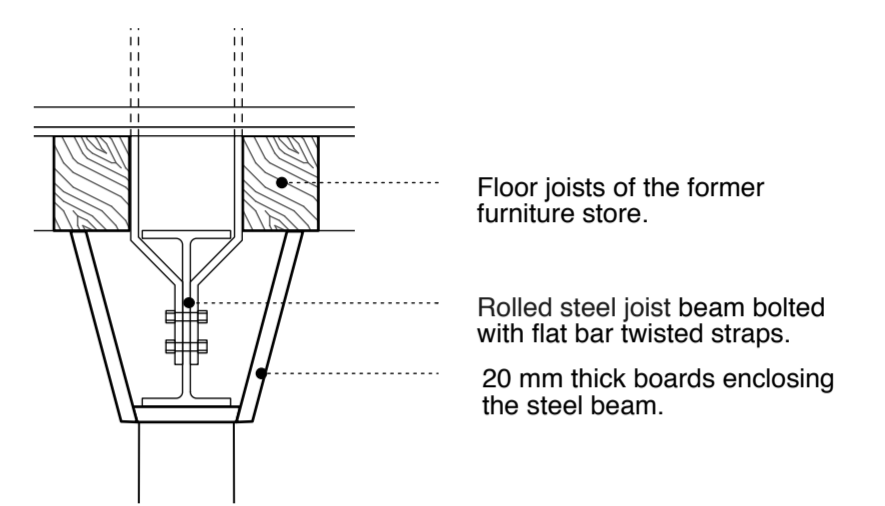
22 Section through metal beam
 Scale: 1:10

Floor joists of the former furniture store.

Rolled steel joist beam bolted with flat bar twisted straps.

20 mm thick boards enclosing the steel beam.

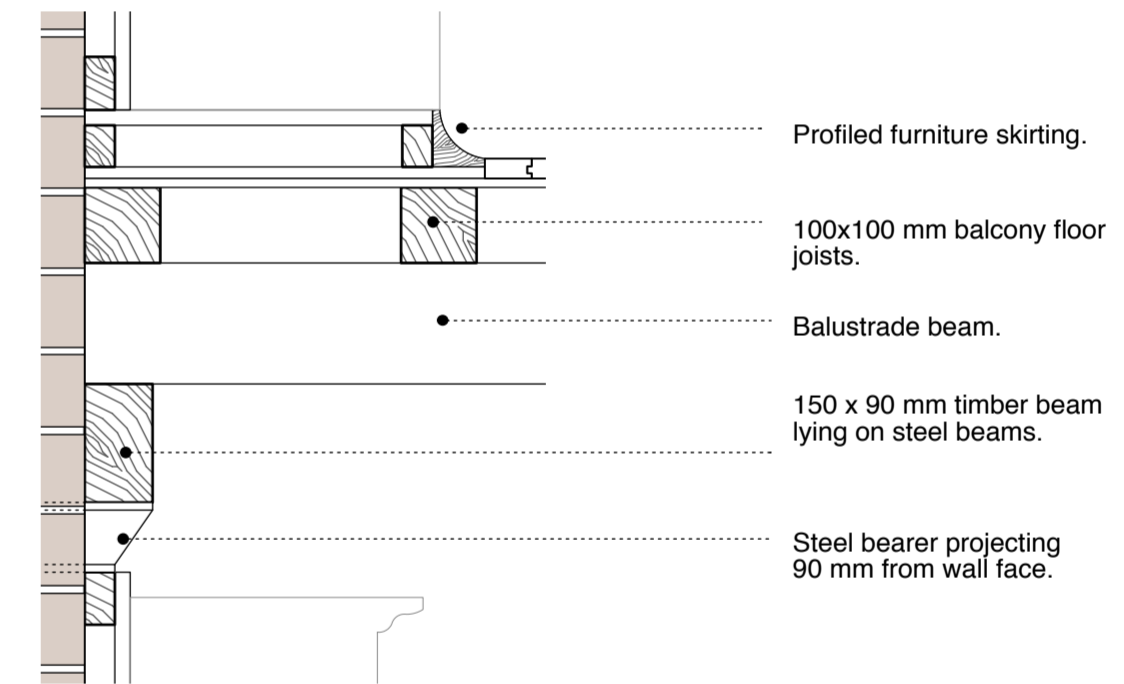
21 Section through timber panels - balcony level
 Scale: 1:10

Profiled furniture skirting.

100x100 mm balcony floor joists.

Balustrade beam.

150 x 90 mm timber beam lying on steel beams.

Steel bearer projecting 90 mm from wall face.

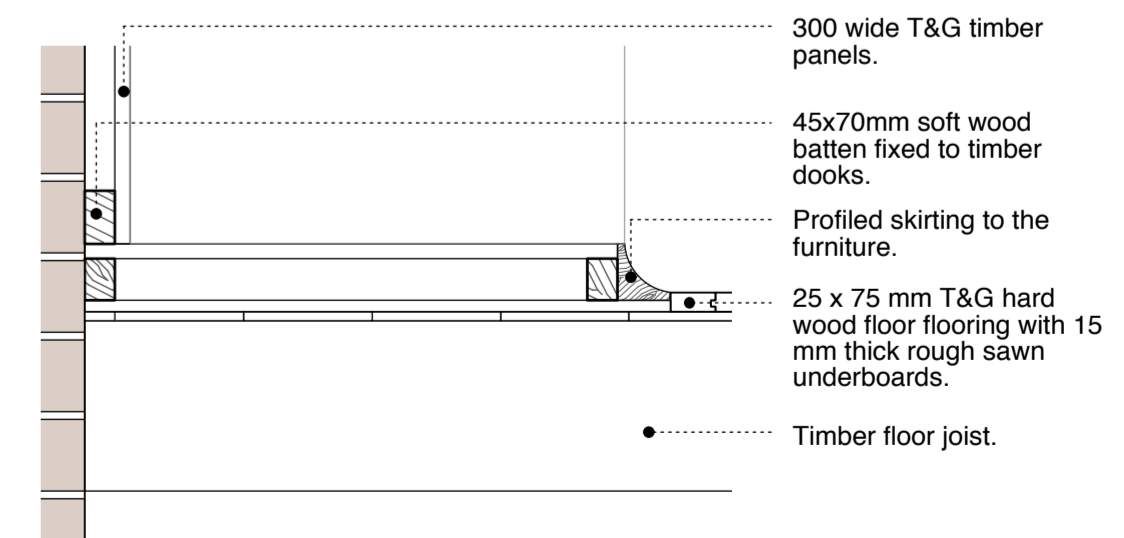
20 Section through timber panels
 Scale: 1:10

300 wide T&G timber panels.

45x70mm soft wood batten fixed to timber dooks.

Profiled skirting to the furniture.

25 x 75 mm T&G hard wood floor flooring with 15 mm thick rough sawn underboards.

Timber floor joist.
